BRAYARCHITECTS

contents

sparta high school building systems summary

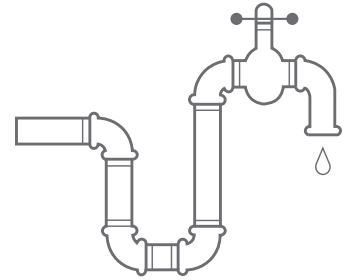
Replace Original 1962 Water Service

Domestic Water System	■	
Water Service	●	4" piping in 1962 portion of building is reaching the end of expected service life 4" piping in 2000 portion of building is ductile iron with corrosion at meter
Water Distribution Piping	●	Piping nearing end of expected service life
Water Softening System	○	
Fire Sprinkler System	○	
Sanitary System	■	
Sanitary Waste System	●	
Sanitary Drain, Waste + Vent Piping	●	1962 portion of building is reaching end of expected service life
Acid Waste Piping + Basin	●	
Interceptors	●	
Sump Pump	●	
Storm System	■	
Storm System	●	
Storm Waste Piping	●	Drain piping in original building portion is reaching end of expected life cycle
Sump Pump	○	
Natural Gas System	■

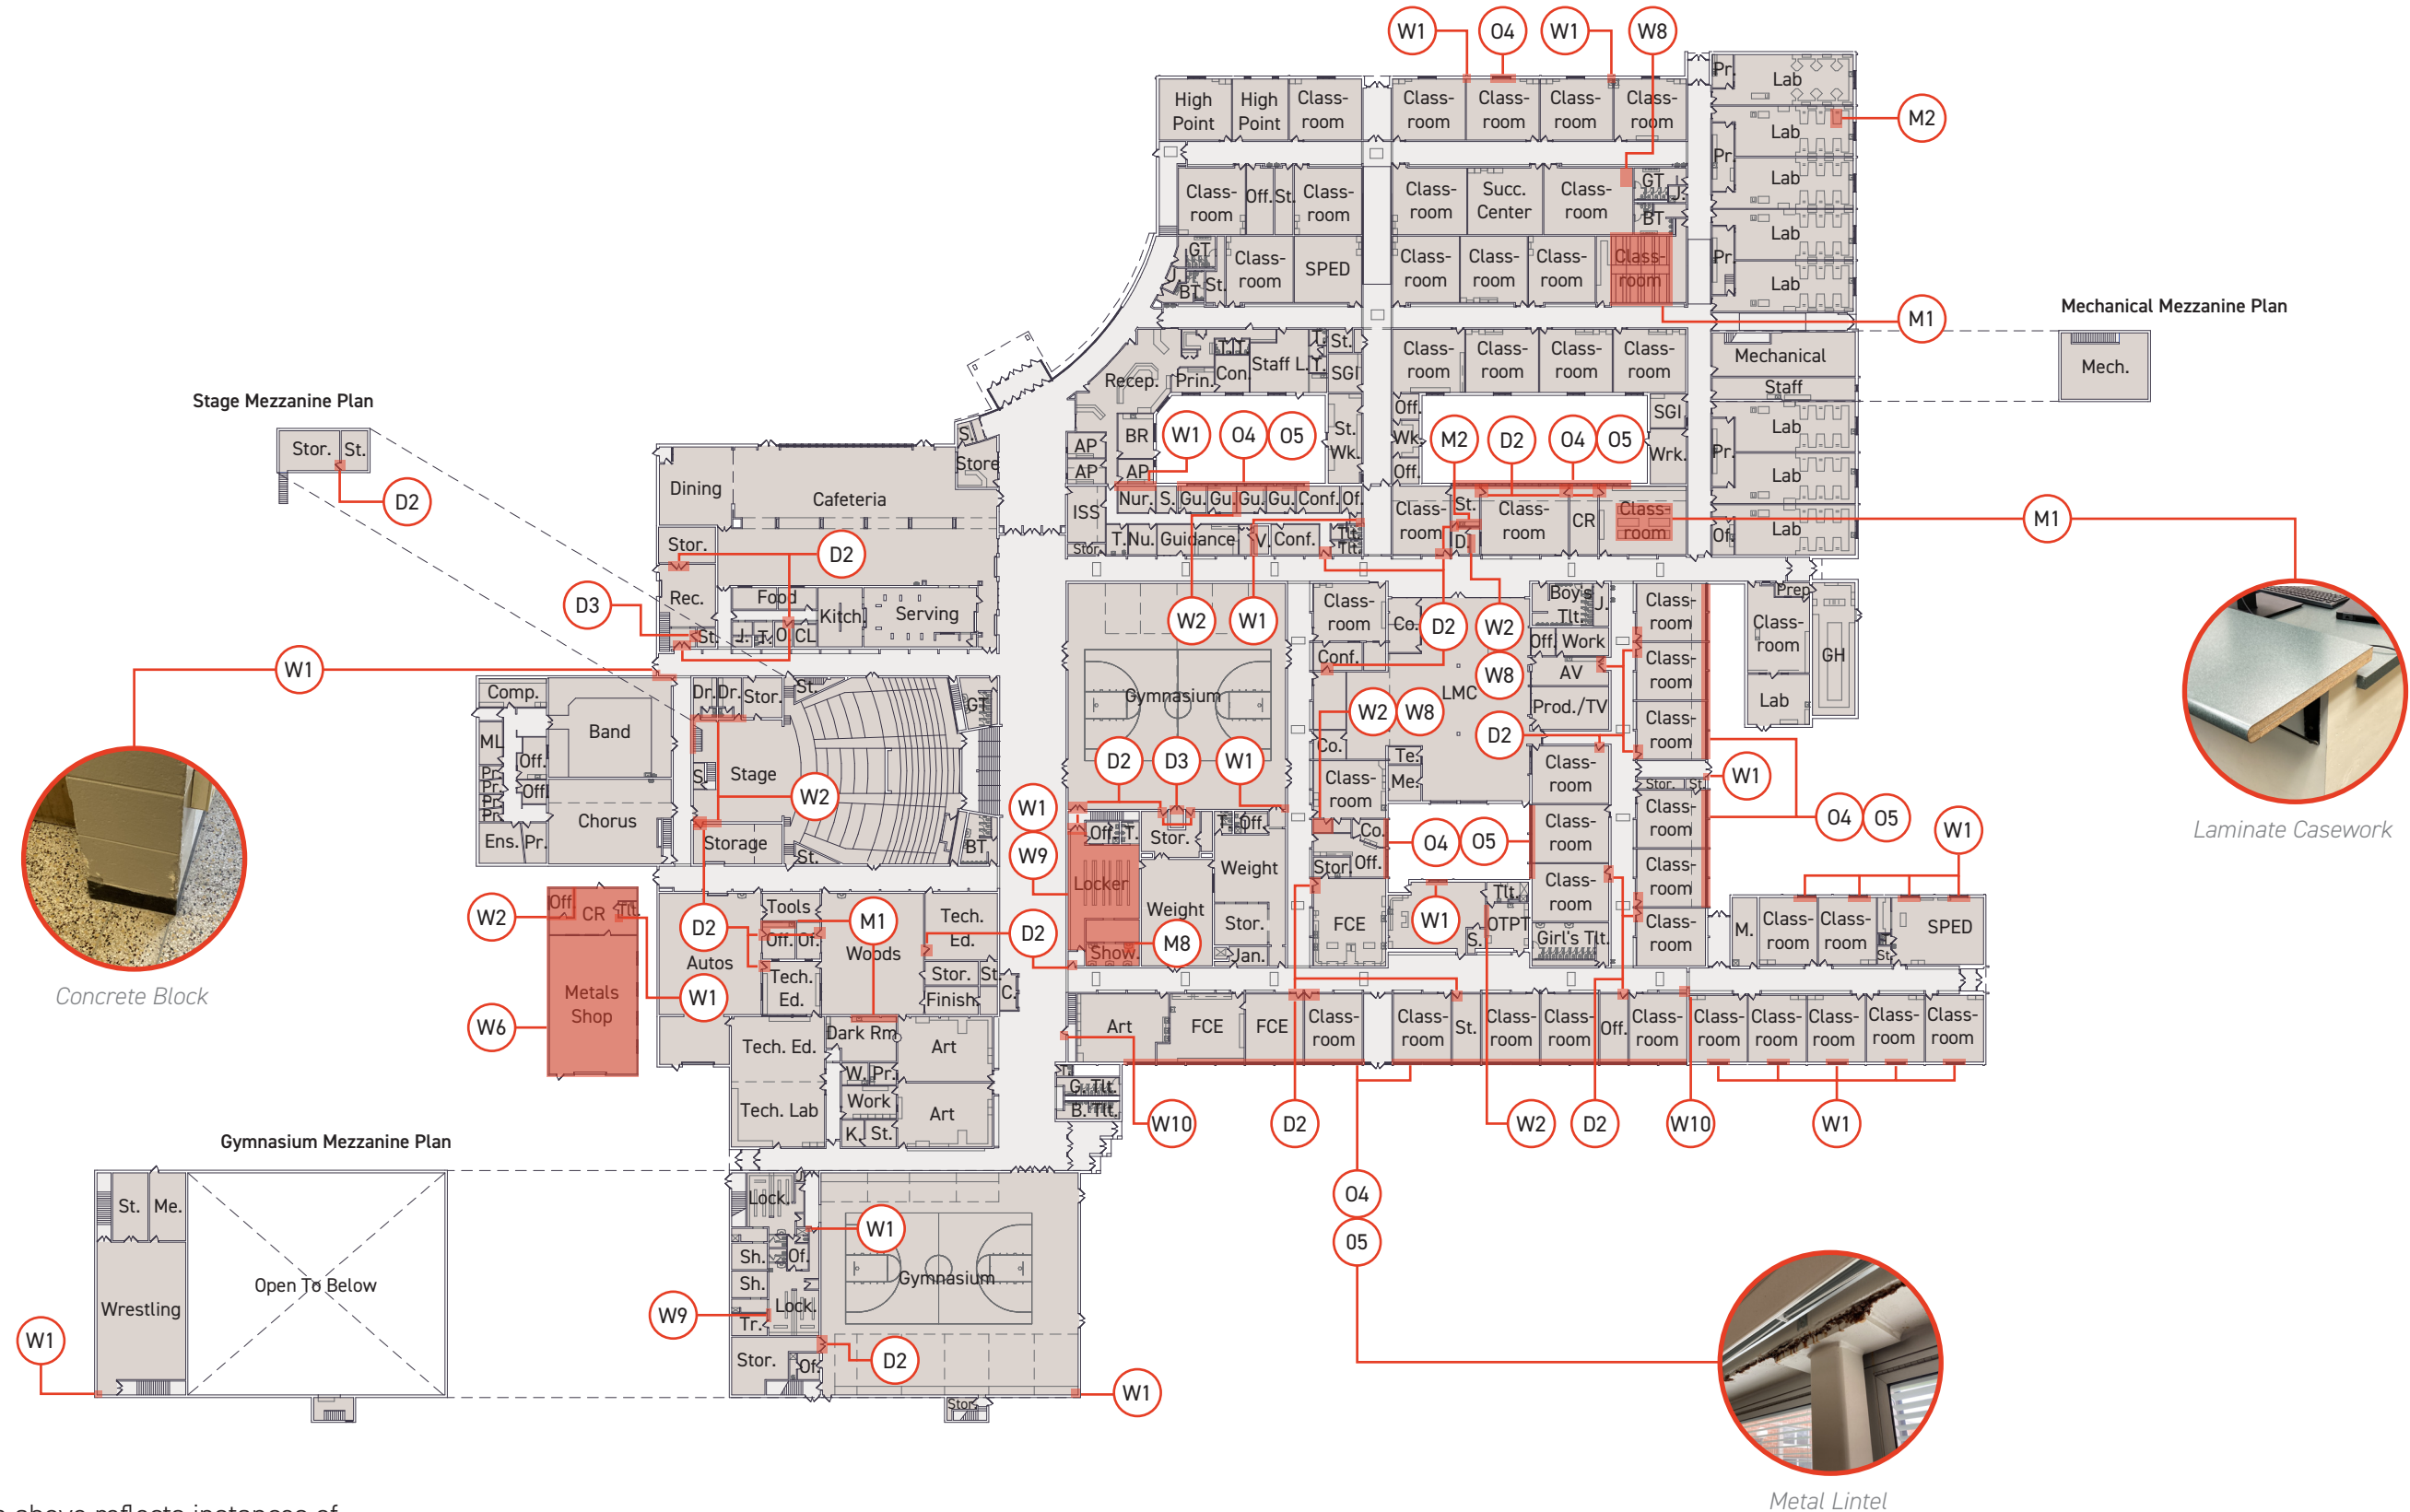
sparta high school interior identifications + analysis | lower level

- Majority of the metal lintels located in the original 1962 building are in poor condition due to rusting and staining.
- The wood doors with hollow metal frames are in fair condition overall, but there are many instances of poor condition due to scratching, denting, and fading.
- Majority of the gypsum walls located throughout the building are in fair condition, except a few instances that are in poor condition due to cracking and chipping of paint.
- There are few instances of concrete block in poor condition due to chipping, cracking, and scratching.
- The concrete block above the windows in the south portion of the 1990 addition are in poor condition due to cracking.

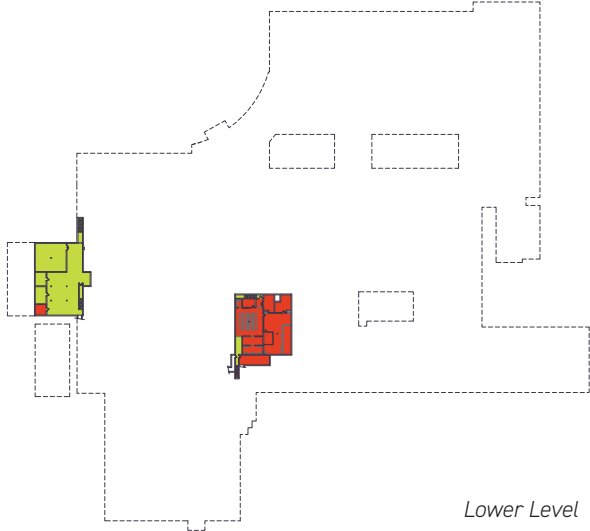
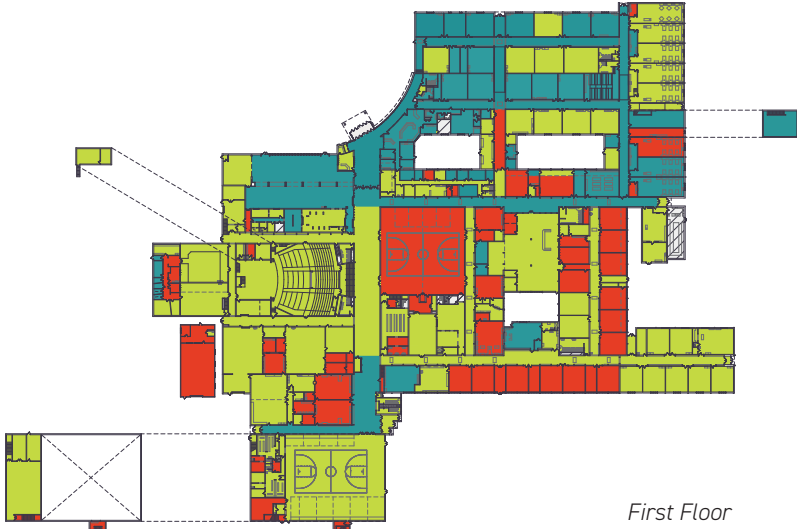
sparta high school ceiling analysis

- Materials identified as potentially containing asbestos are considered to be in poor condition.
- Spline ceilings are identified as a potential asbestos containing material.
- Majority of acoustical ceiling tile located in the north side of the school are in good condition due to few instances of staining or warping.
- Majority of classrooms with concrete ceilings are in poor condition due to cracking.

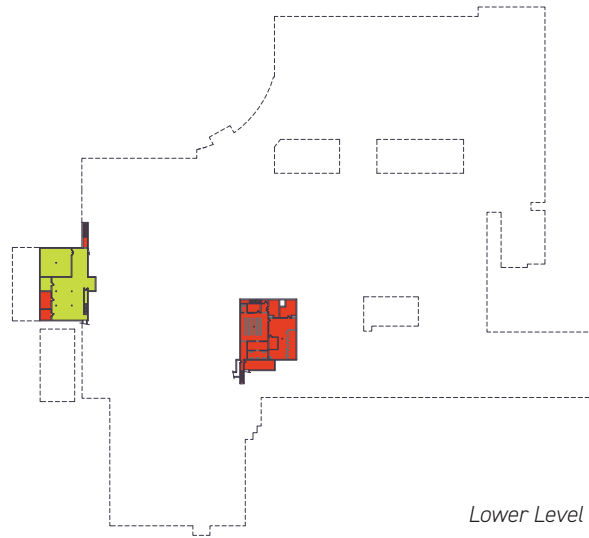
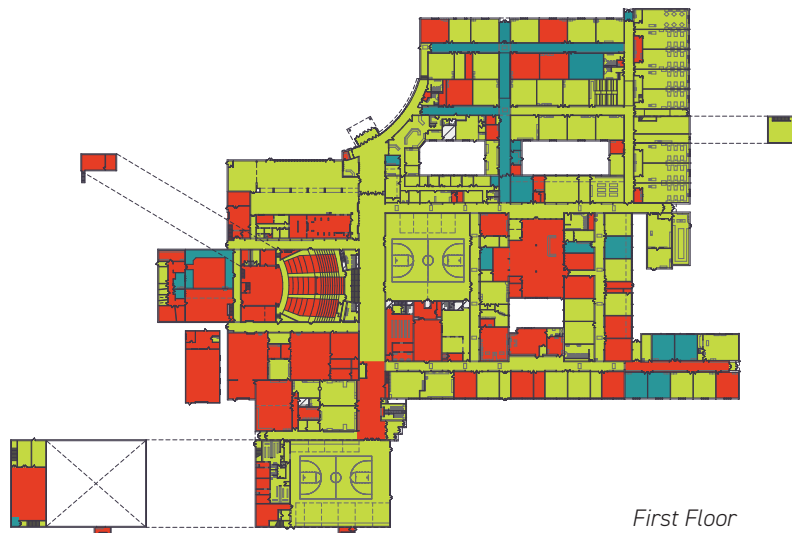
sparta high school flooring analysis

- Materials identified as potentially containing asbestos are considered to be in poor condition.
- 9" x 9" vinyl tile flooring is identified as potential asbestos tile.
- There are instances of concrete flooring located in the lower level that are in poor condition due to cracking and staining.
- Majority of VCT flooring is in fair condition due to minor scratching and wear.

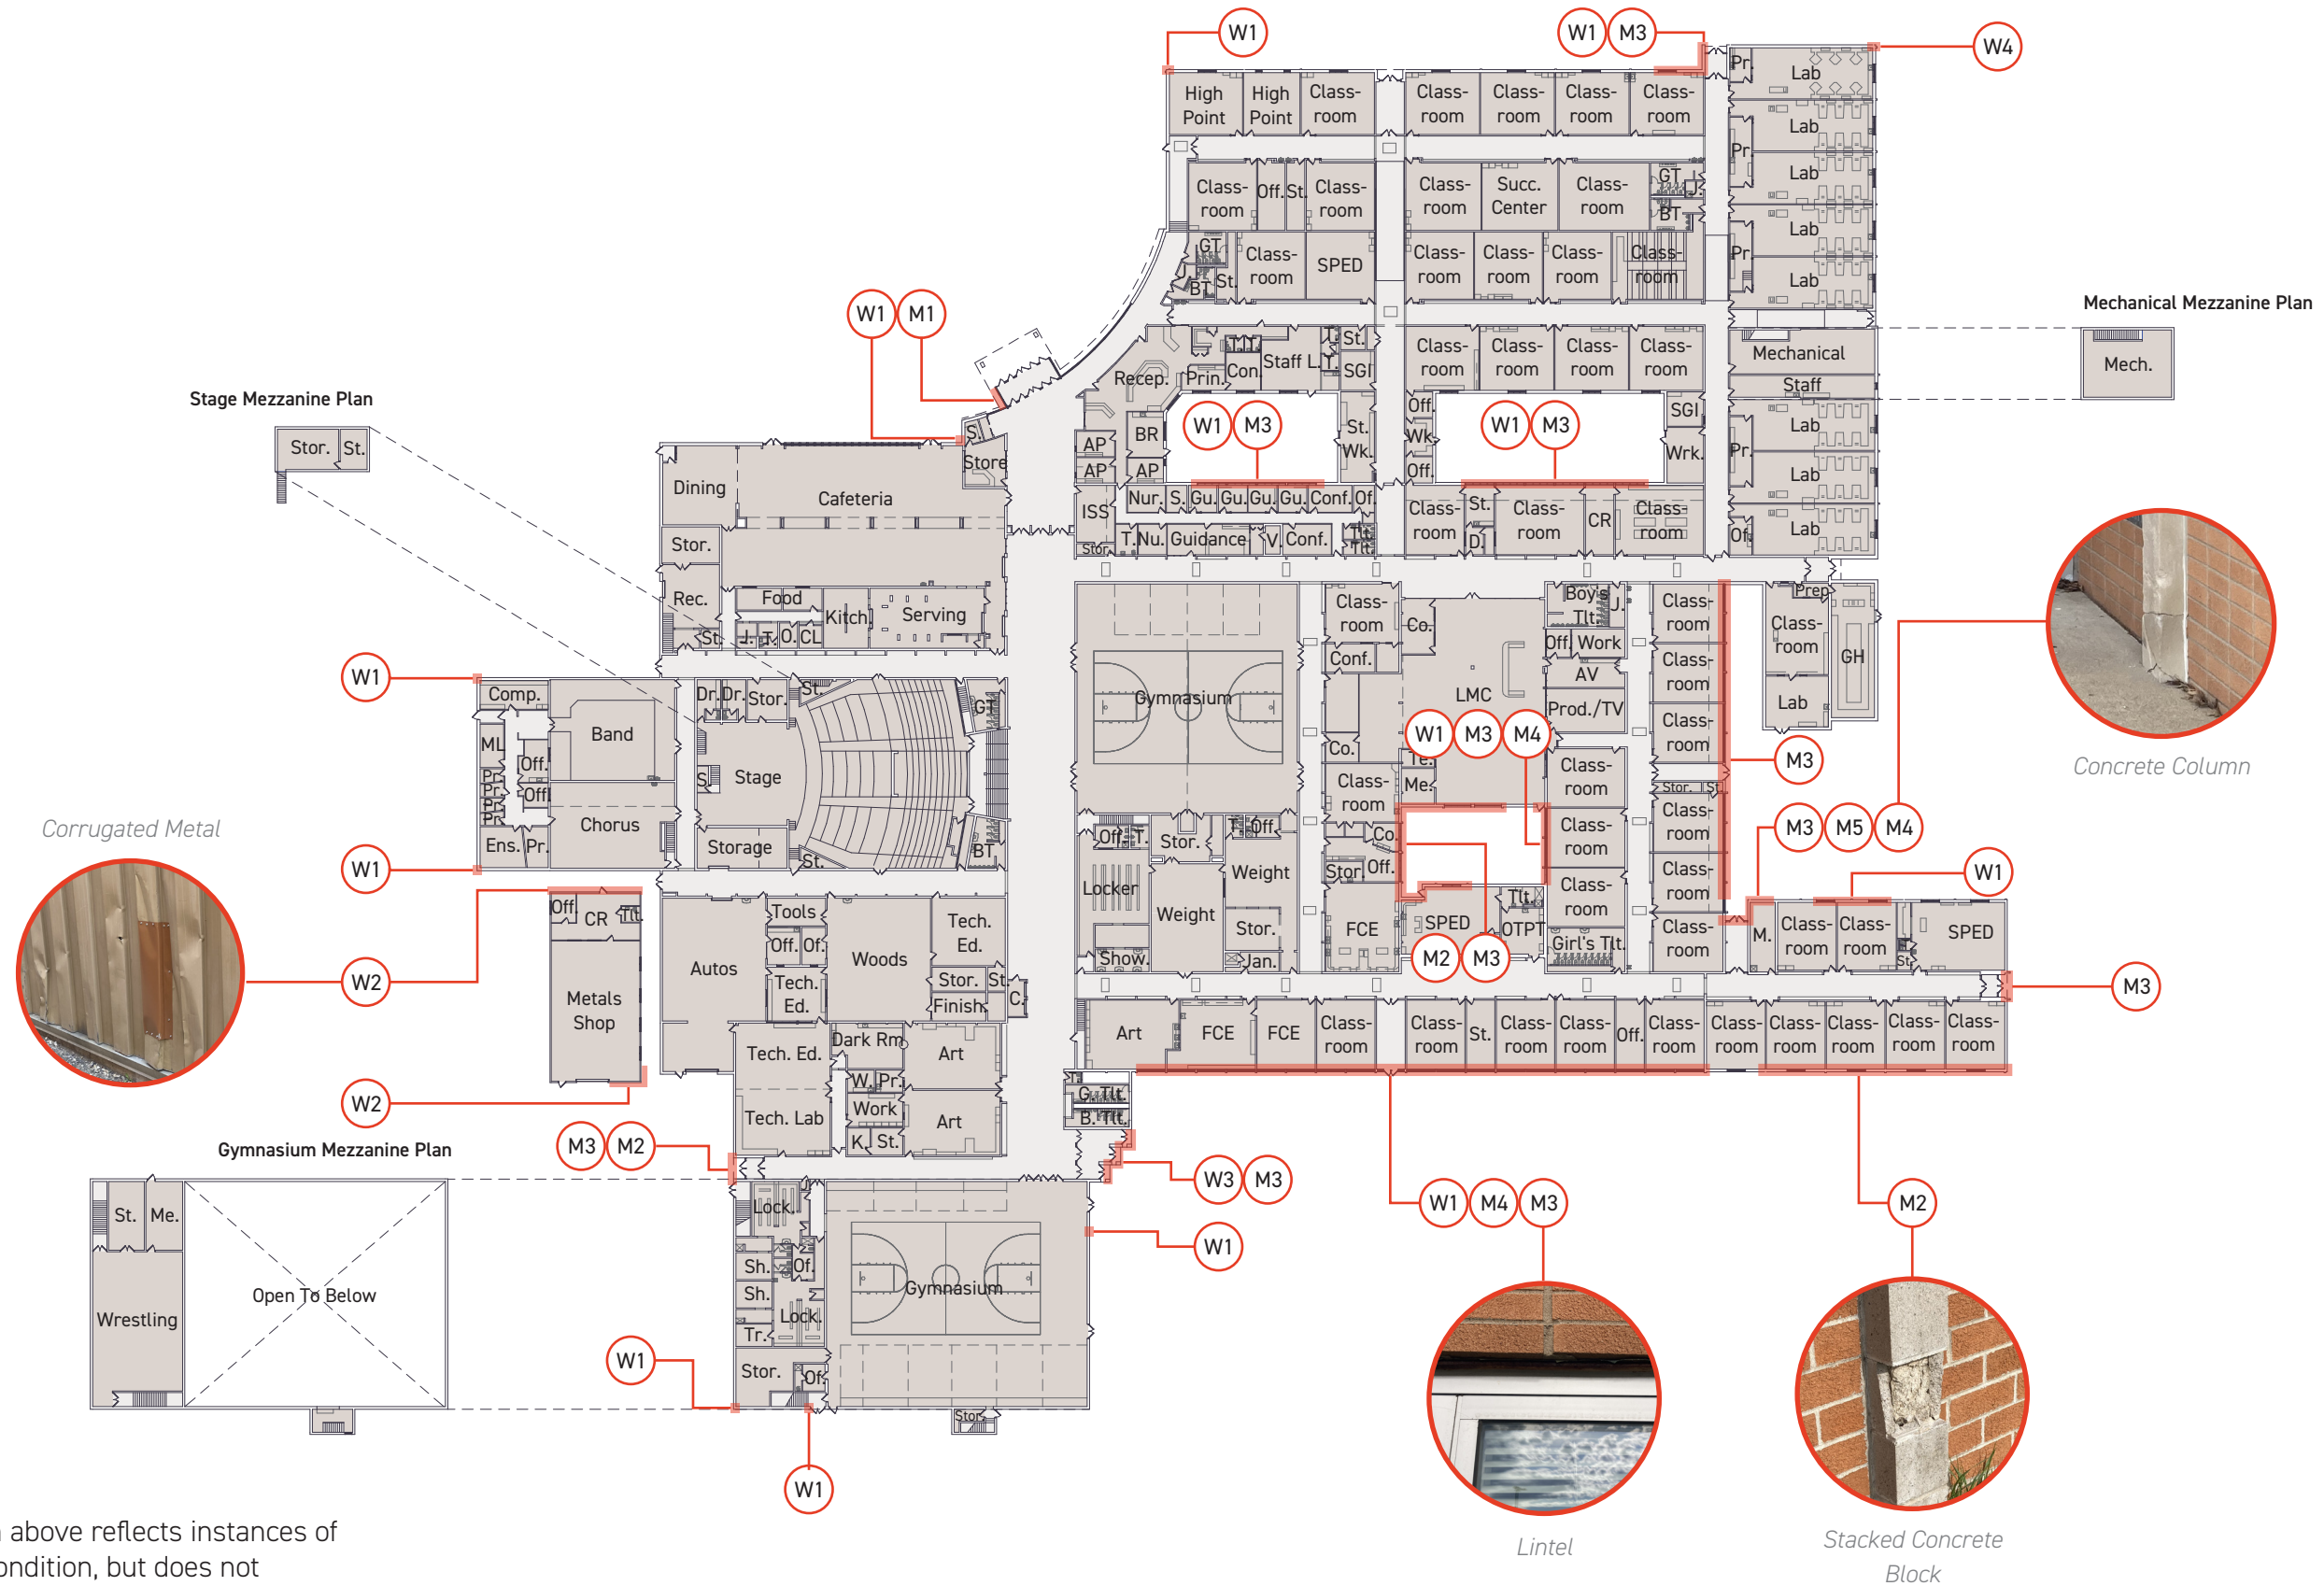
sparta high school exterior identifications + analysis

- Brick work contains cracking and chipping sporadically throughout exterior. Brick work on southwest side on original building portion shows signs of bowing/bulging.
- Majority of the metal lintels located above the doors and windows are in poor condition due to rusting.
- Concrete columns and stacked concrete blocks are in poor condition due to cracking and crumbling.
- Corrugated metal facade of the industrial arts building shows excessive denting, scratching, and puncturing.

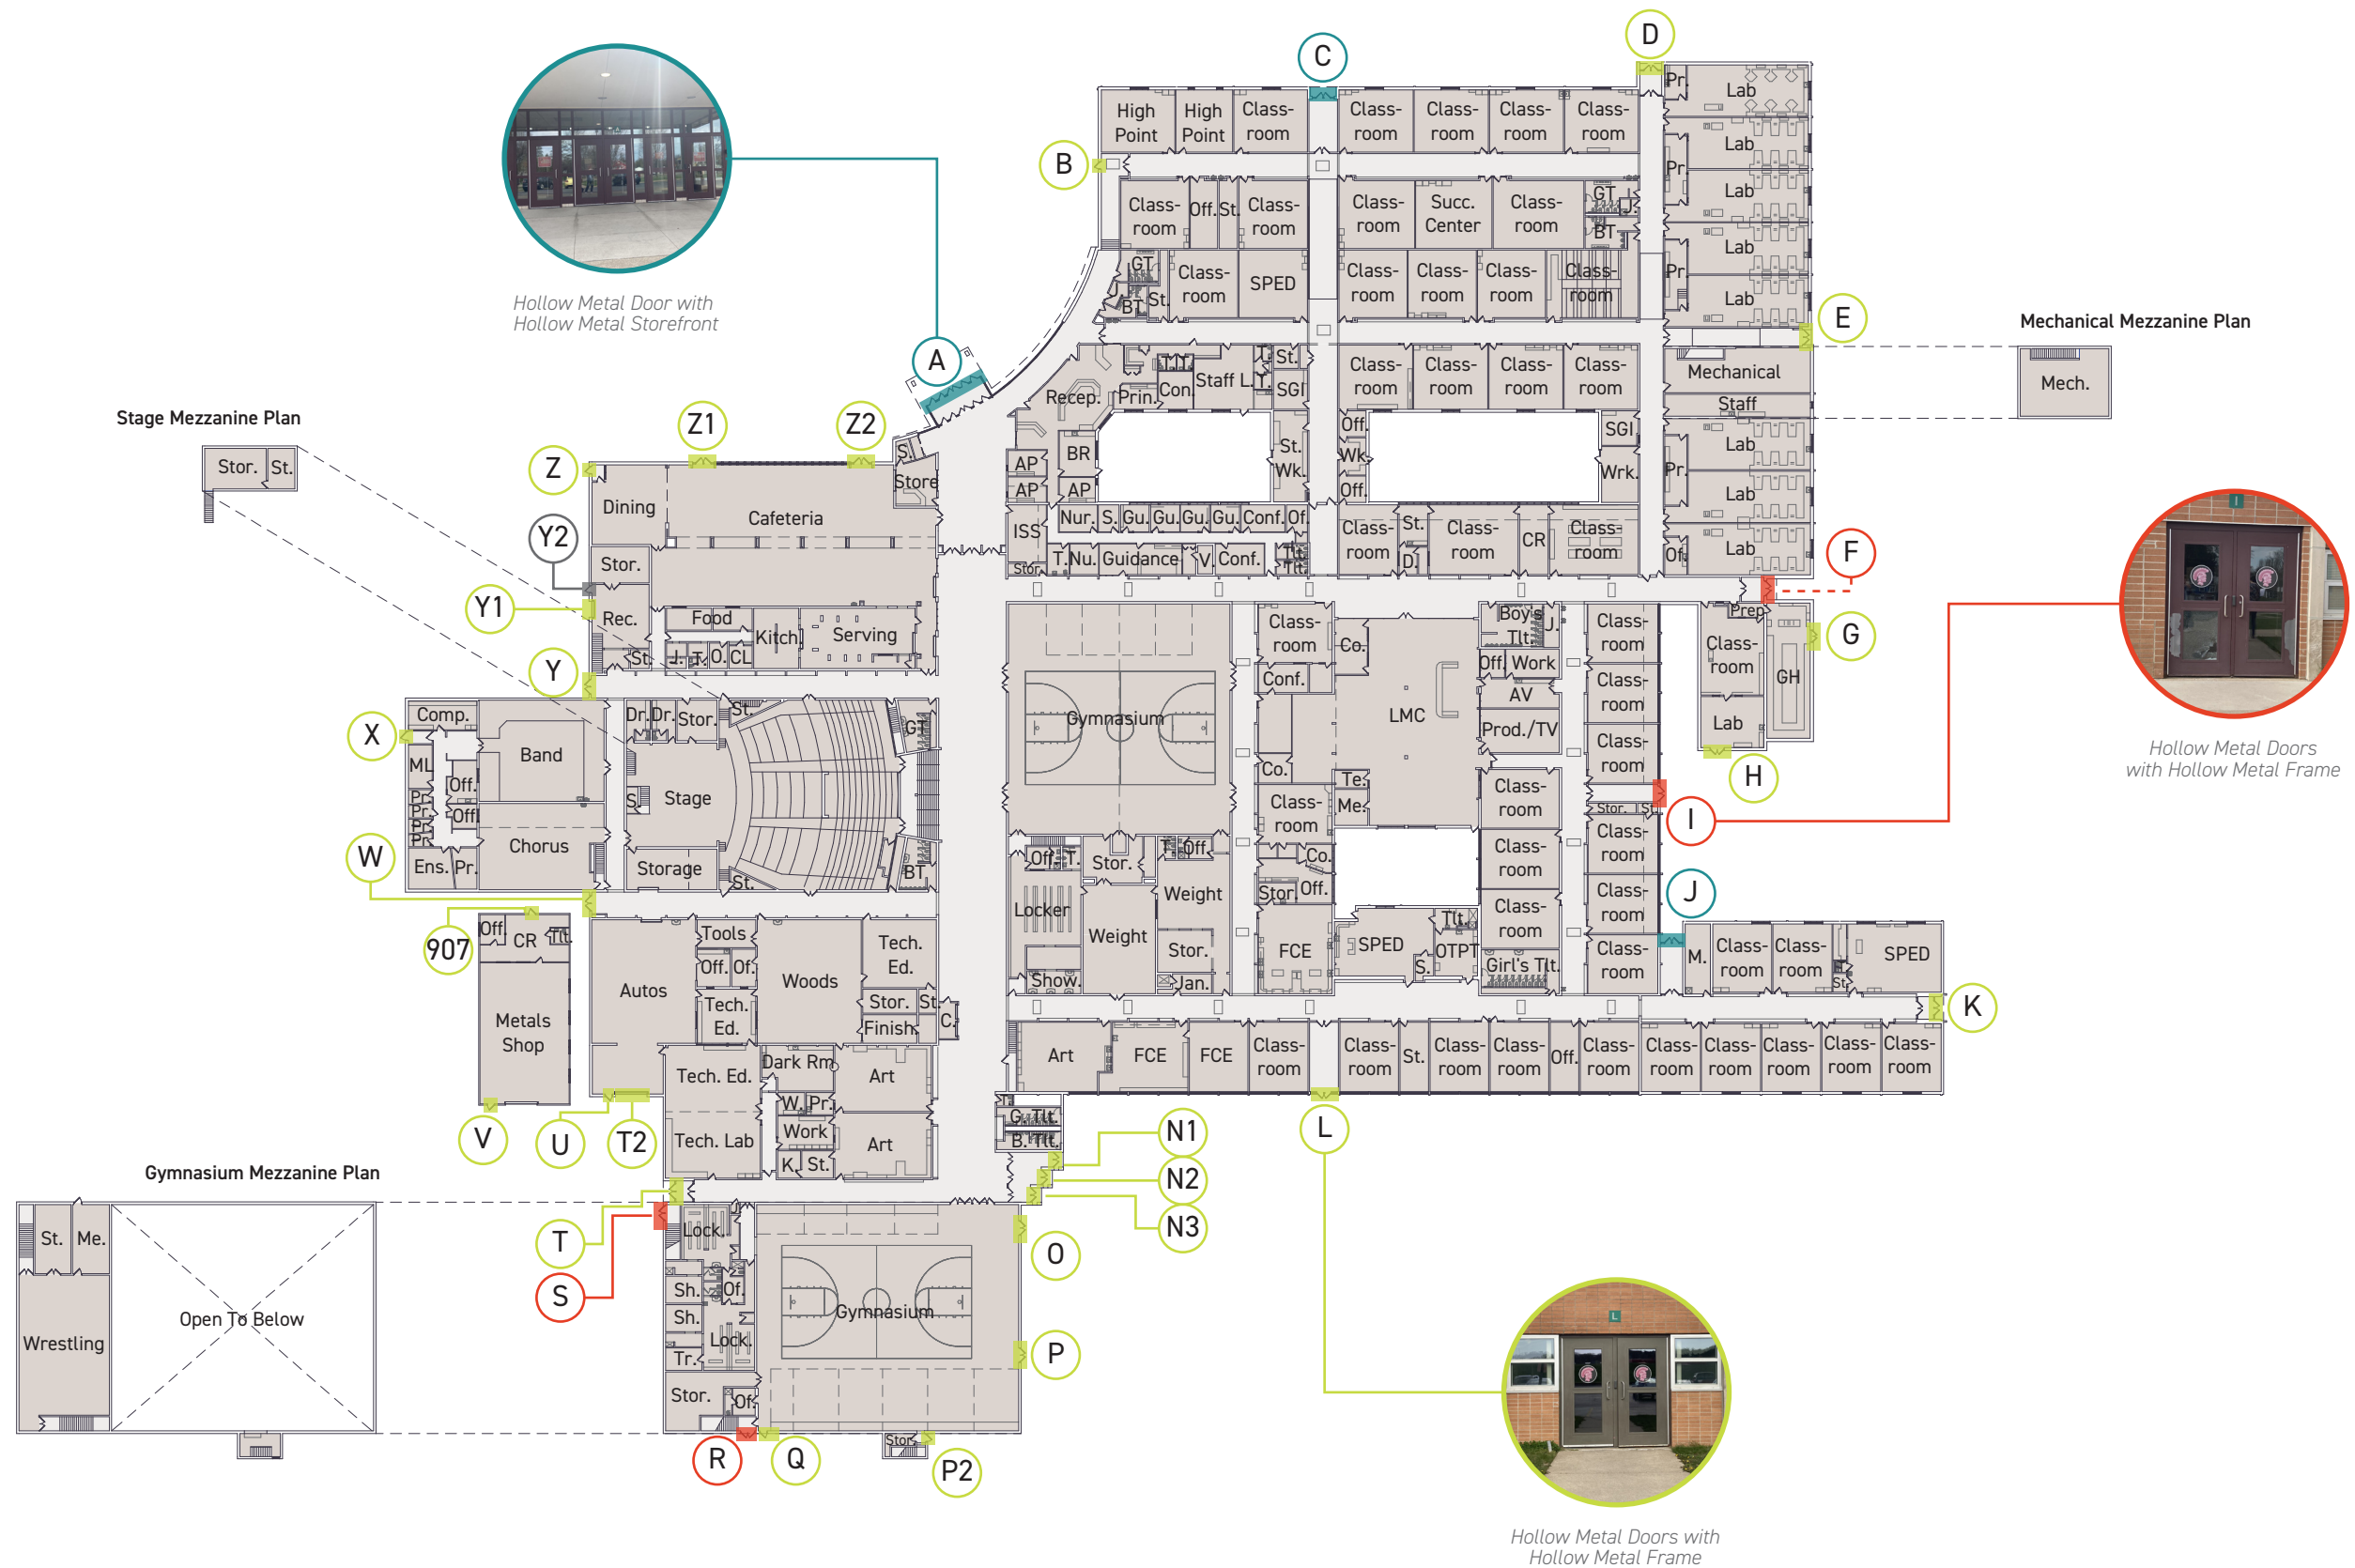
sparta high school exterior door identification + analysis

- The gymnasium exterior doors are in fair or poor condition due to rusting, staining, denting, or peeling of paint.
- Door I is in poor condition due to paint peeling, rusting, and broken glazing.
- Majority of hollow metal doors with hollow metal framing are in fair condition due to scratching of paint or fading of color.

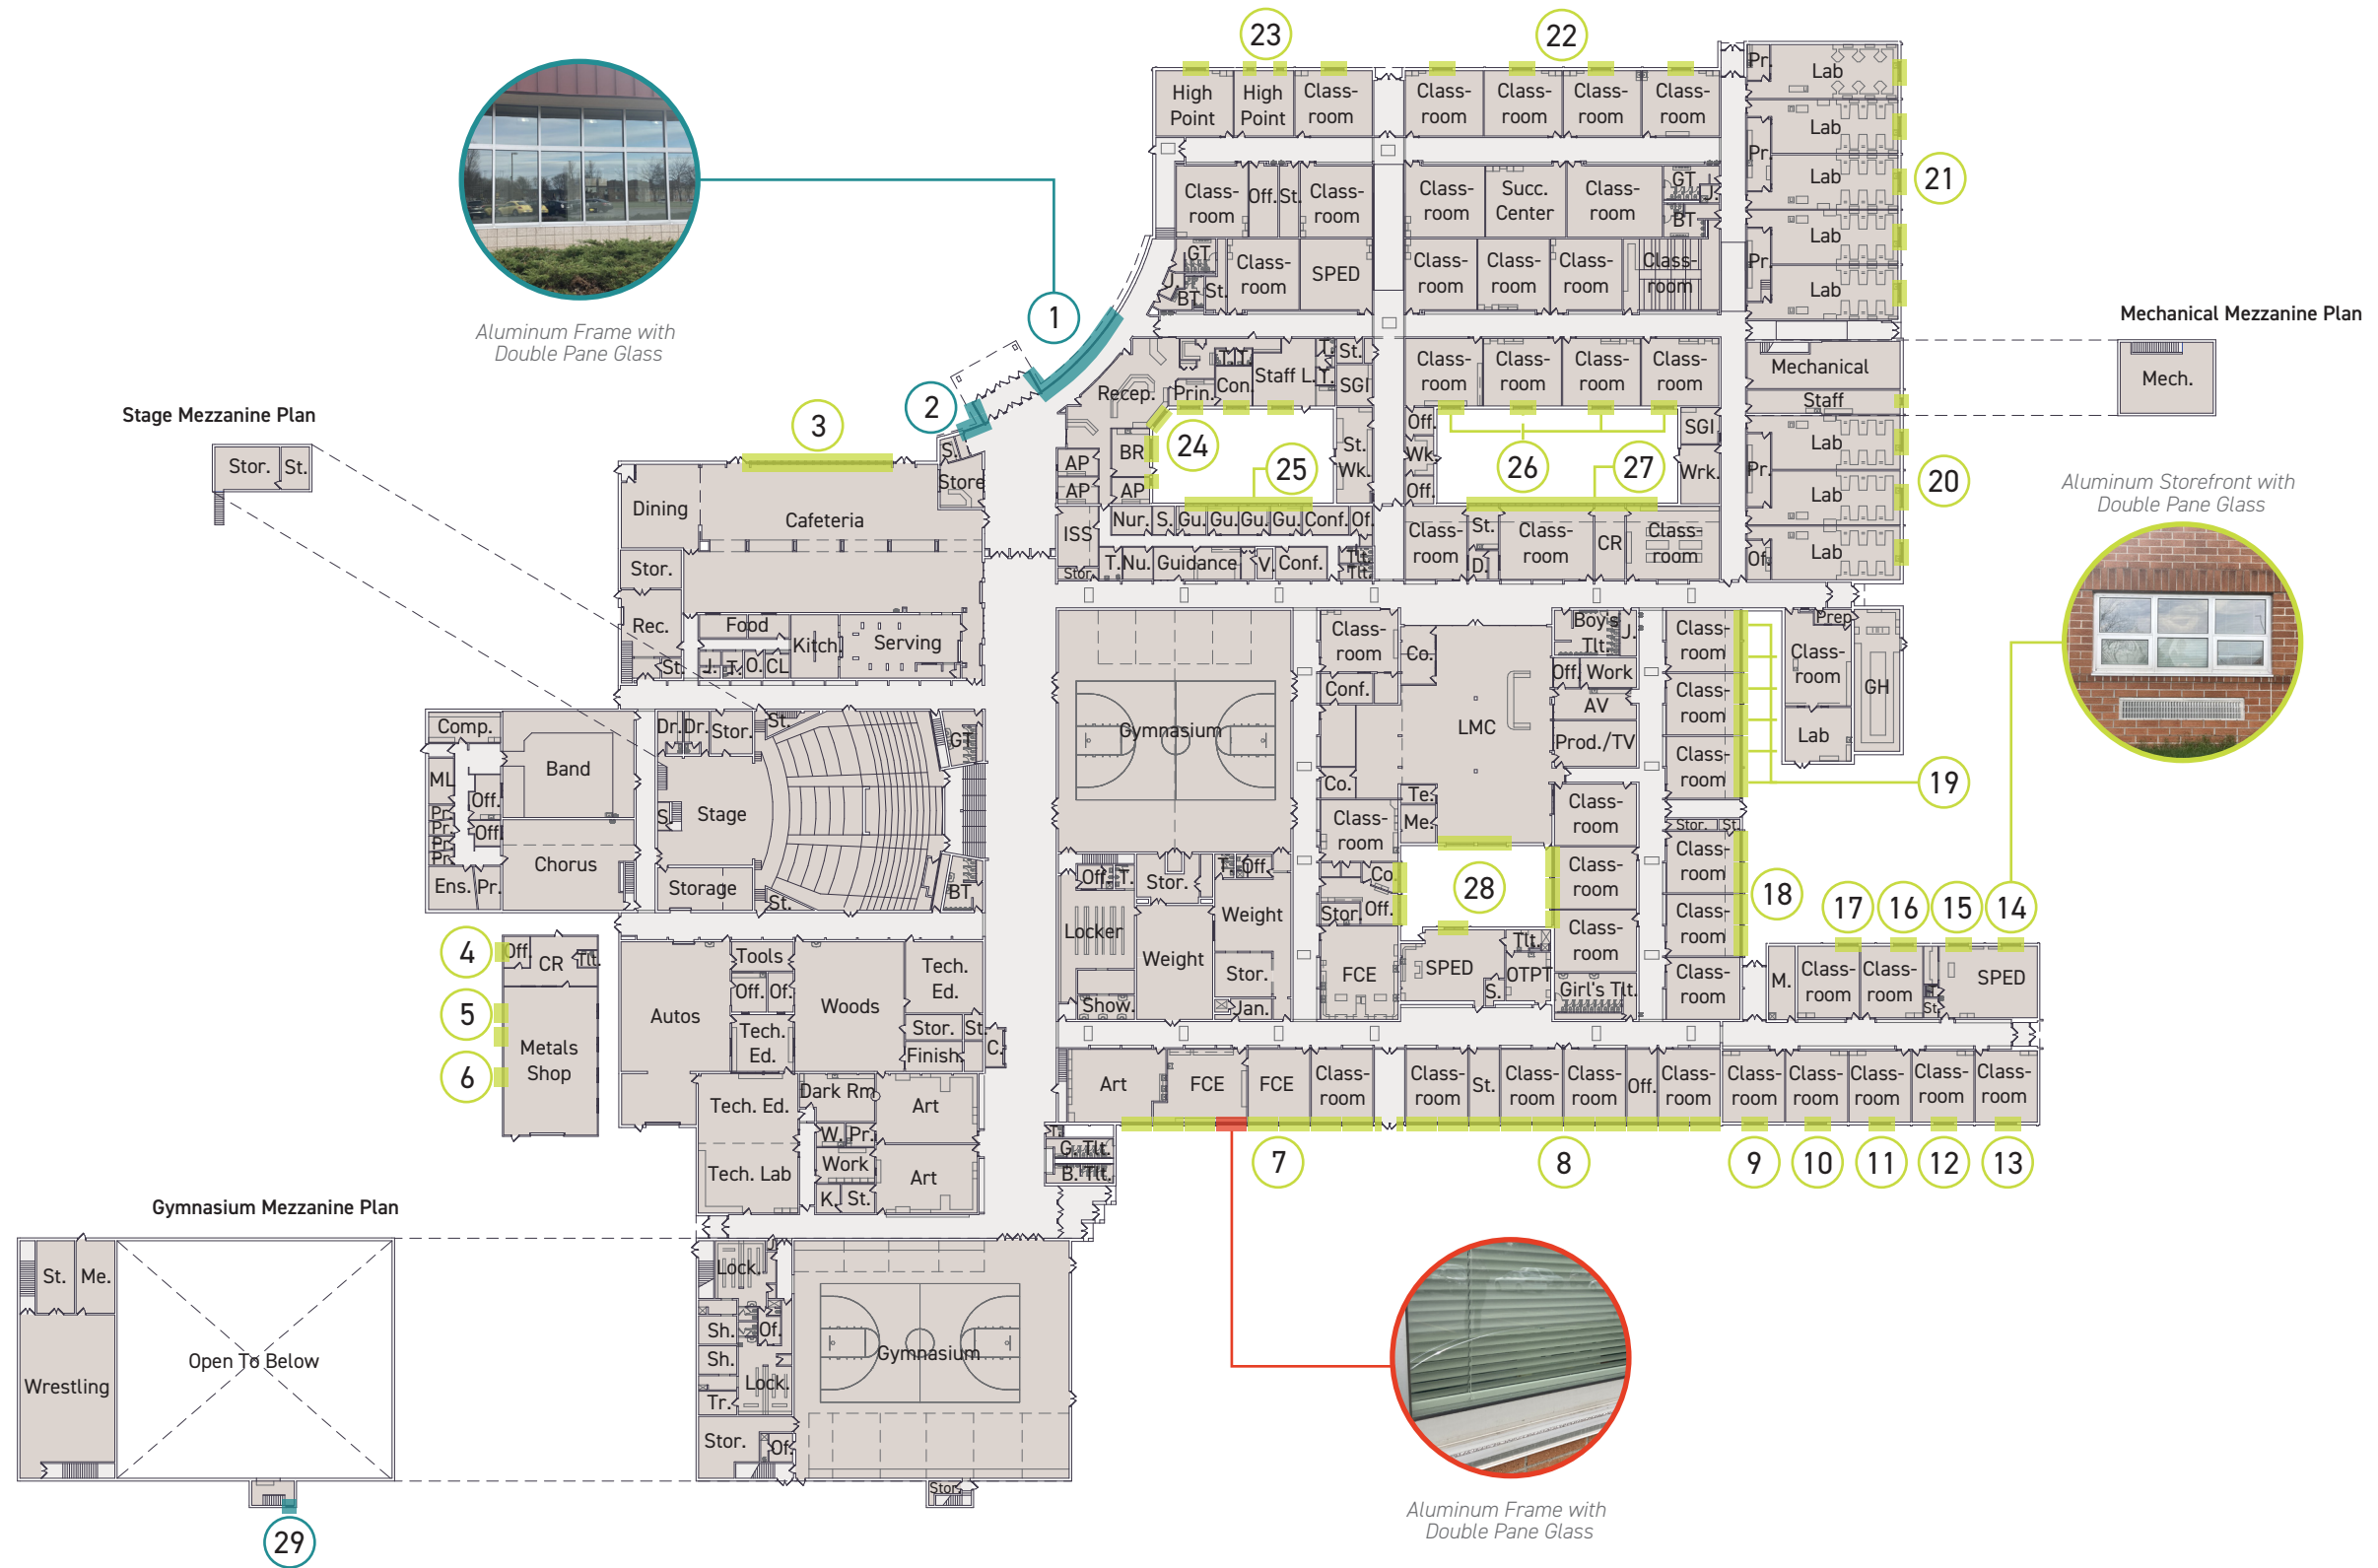
sparta high school exterior window identification + analysis

- Majority of the aluminum framed windows with double pane glass are in fair condition with slight wear and occasional rusting.
- There is an instance at windows 7 where a crack is visible.

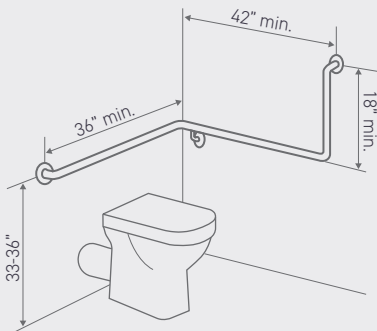
Not providing at proper grab bars at ADA accessible toilet.

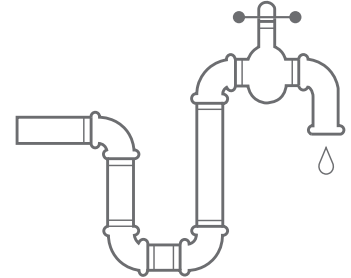
Replace Water Service + Replace Original Water Distribution Piping

Domestic Water System	■	
Water Service	●	Existing water service dates back to original building construction with copper piping installed downstream in 1990. Original water service likely in very poor condition
Water Distribution Piping	●	Distribution piping is mix of copper, galvanized steel, CPVC, black steel, and PEX piping. Piping is not adequately supported or insulated. If original piping is present it's in poor condition
Water Softening System		
Fire Sprinkler System		
Sanitary System	■	
Sanitary Waste System	●	
Sanitary Drain, Waste + Vent Piping	●	Original piping is past its expected life cycle
Acid Waste Piping + Basin		
Interceptors	●	
Storm System	■	
Storm System	●	
Storm Waste Piping	●	Original piping is past its expected life cycle
Sump Pump	●	
Natural Gas System

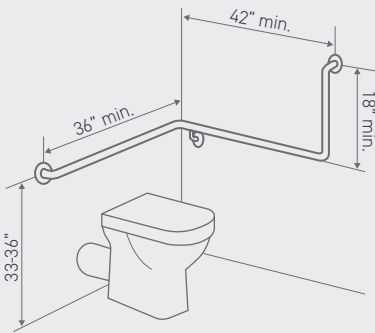
Not providing at proper grab bars at ADA accessible toilet.
