Sparta Area School District

District-wide Facilities Study

DRAFT

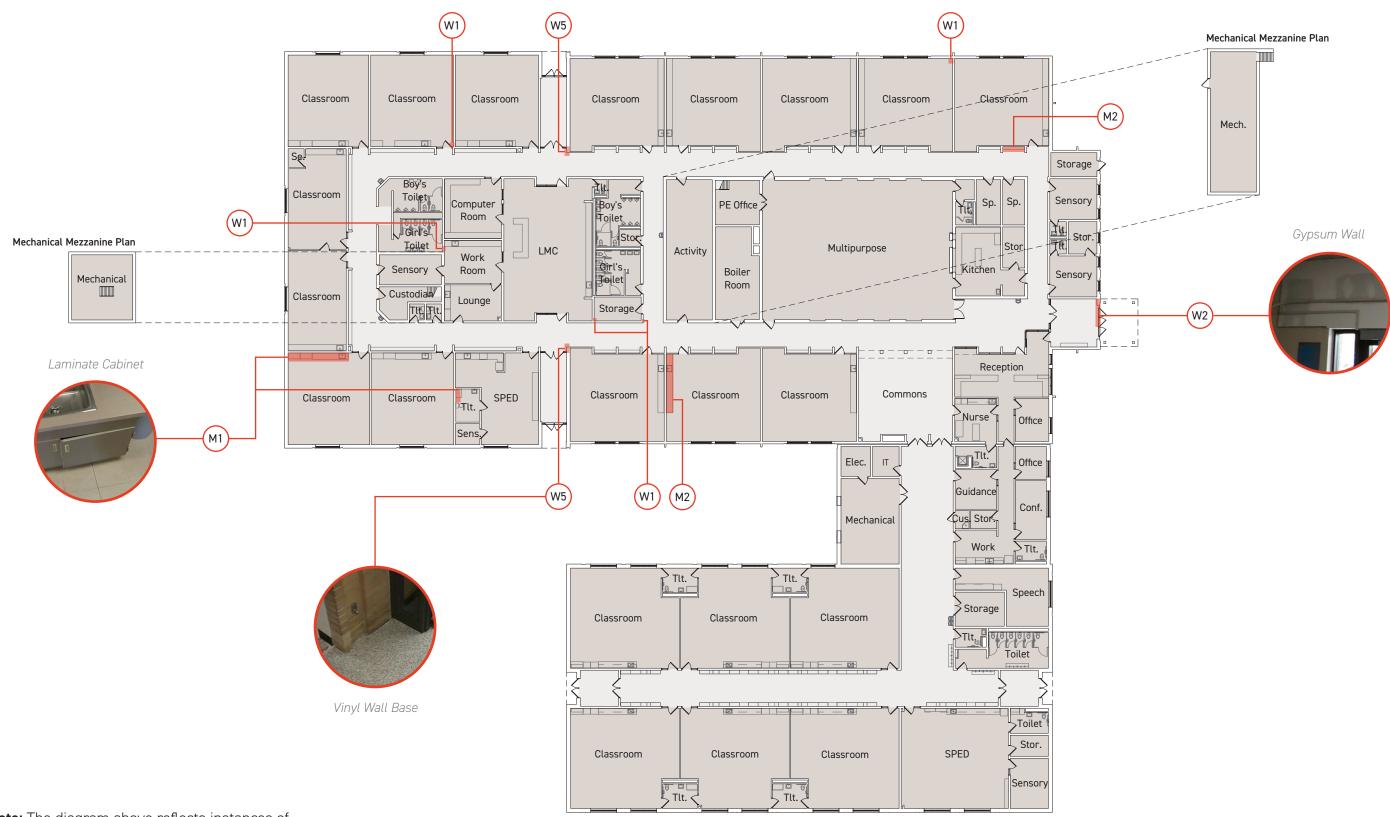
southside early learning center interior identifications + analysis | first floor

- Majority of the casework located in the 1965 and 1990 addition are in fair condition due to some staining and worn finish. There are a few instances of casework in poor condition due to sagging doors, staining, and scratching.
- Wood doors located in the 1965 and 1990 addition are in fair condition due to staining, scratching, and worn finish.
- · Majority of the concrete block walls located in the building are in fair condition due to minor scratching.

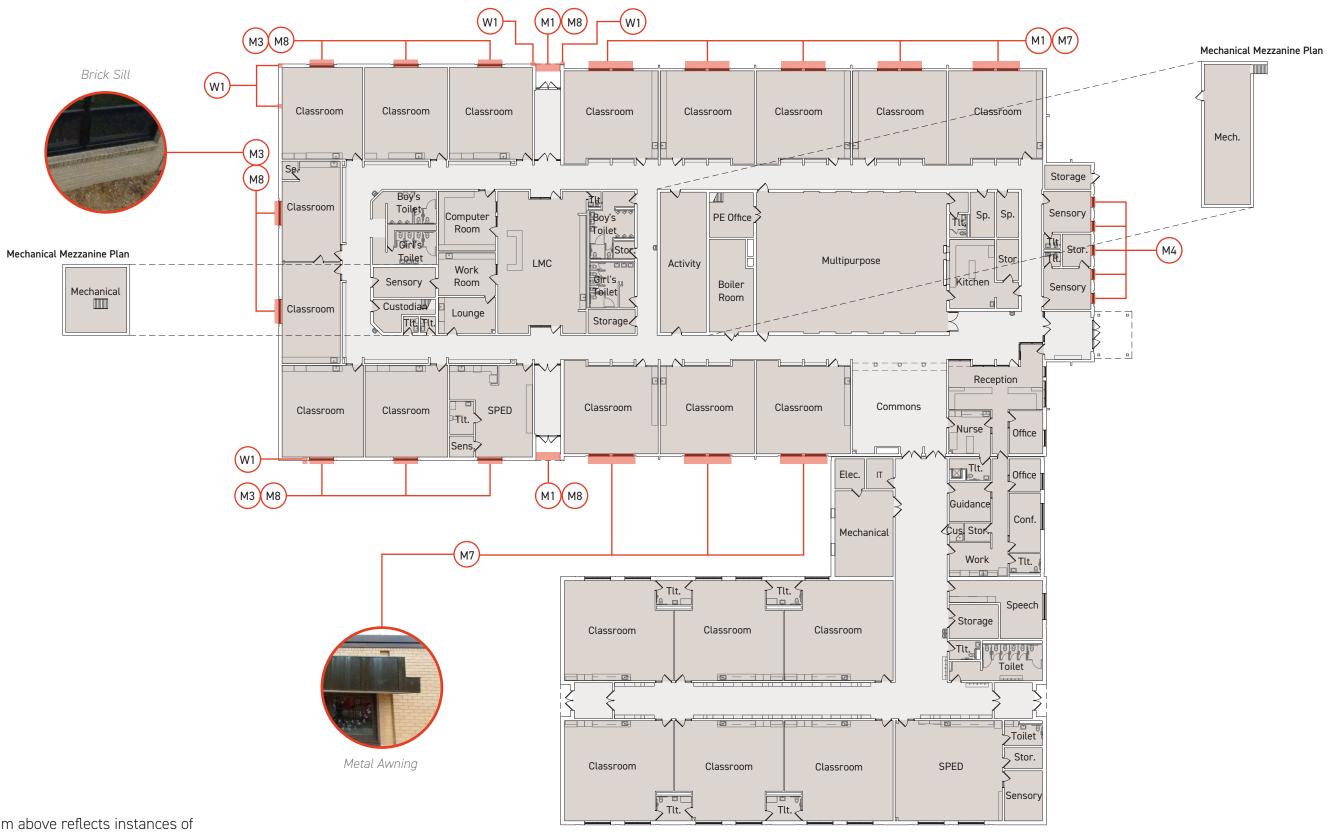
southside early learning center exterior identifications + analysis

- There is effervesce present on the bottom of the brick wall located on the 2019 addition adjacent to the playground.
- · Majority of metal lintels located above windows on the 1990 addition are in poor condition due to rusting.
- · Brick walls and sills are in poor condition due to staining on a majority of the 1965 and 1990 addition.
- · Majority of metal awnings are in poor condition due to staining and rusting.

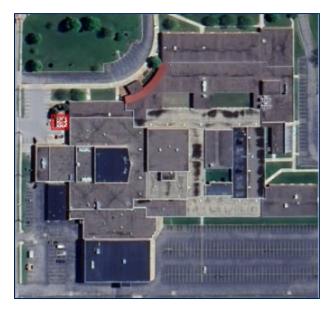
SECTION 27:

Section 27 consists of a freezer type building added onto the main structure. No access was available and the roof was viewed from above. The existing roof system consists of a single ply membrane of unknown type and appears in fair condition. (Refer to photograph #67).

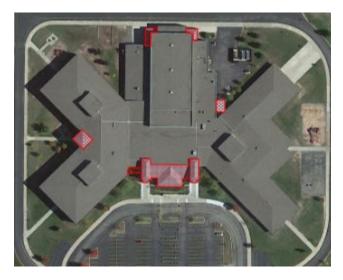
Sheet Metal at Roof Sections 7, 8 and 9:

In general, the standing seam metal roof sections installed at the various entryways to the building are in good condition. Snow retention was provided by a combination of a snow rail attached to the ribs in the standing seam metal panels as well as snow retention devices that were adhered in sealant to the face of the panel. At multiple locations, we noted that the snow retention devices were missing and no longer adhered to the surface of the metal panels. This creates the potential during snow and ice build up to damage the perimeter gutter or to fall below. Refer to photographs #18 and #19).
