FACILITY NEEDS / CHALLENGES

SPARTA MONTESSORI

SPARTA AREA SCHOOL DISTRICT

Sparta Montessori Facility Study Summary

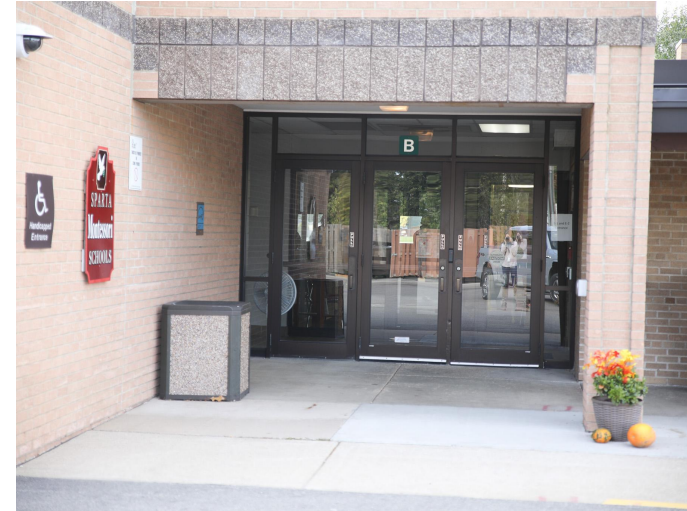
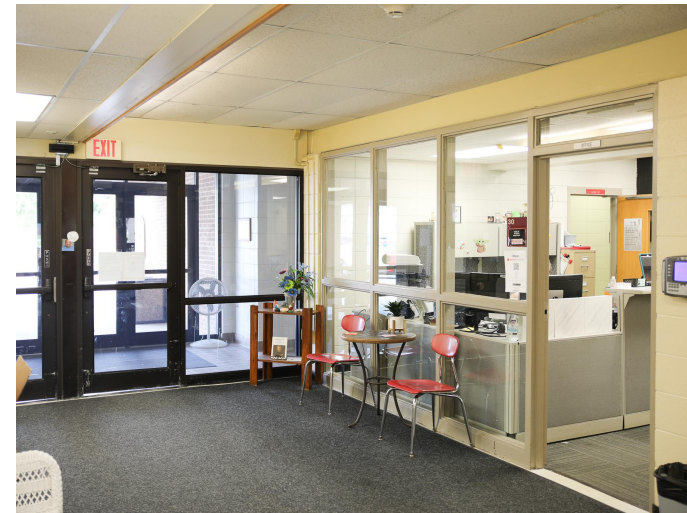
Sparta Montessori Main Office / Secure Entry

- School uses a camera and buzzer system to control access to the building without direct entry into the office (visitors have full access to the building once buzzed in).
- Goal would be to create secure entry check-in like other district buildings (i.e. Herrman & Southside).

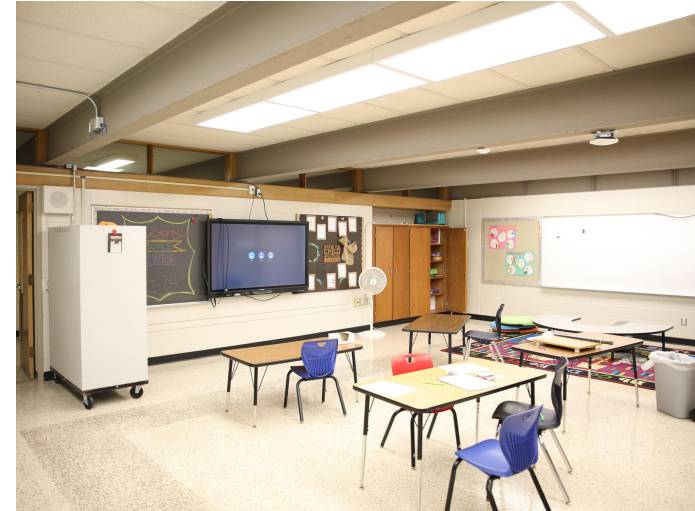
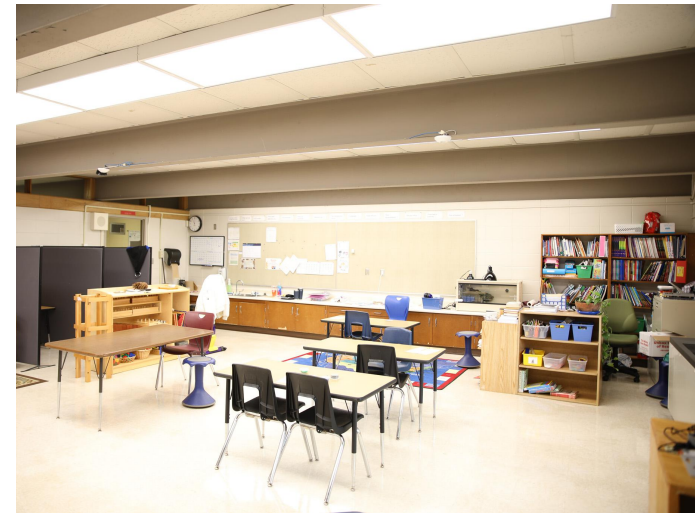
Sparta Montessori General Building Upgrades

- Recent building renovation projects upgraded classrooms for K-6th grade students, with the remaining areas in the building not affected.
- Additional renovation work could be provided in the remainder of the building to further update the building and create the types of spaces needed for a Montessori program.
