BRAYARCHITECTS

contents

sparta high school building systems summary

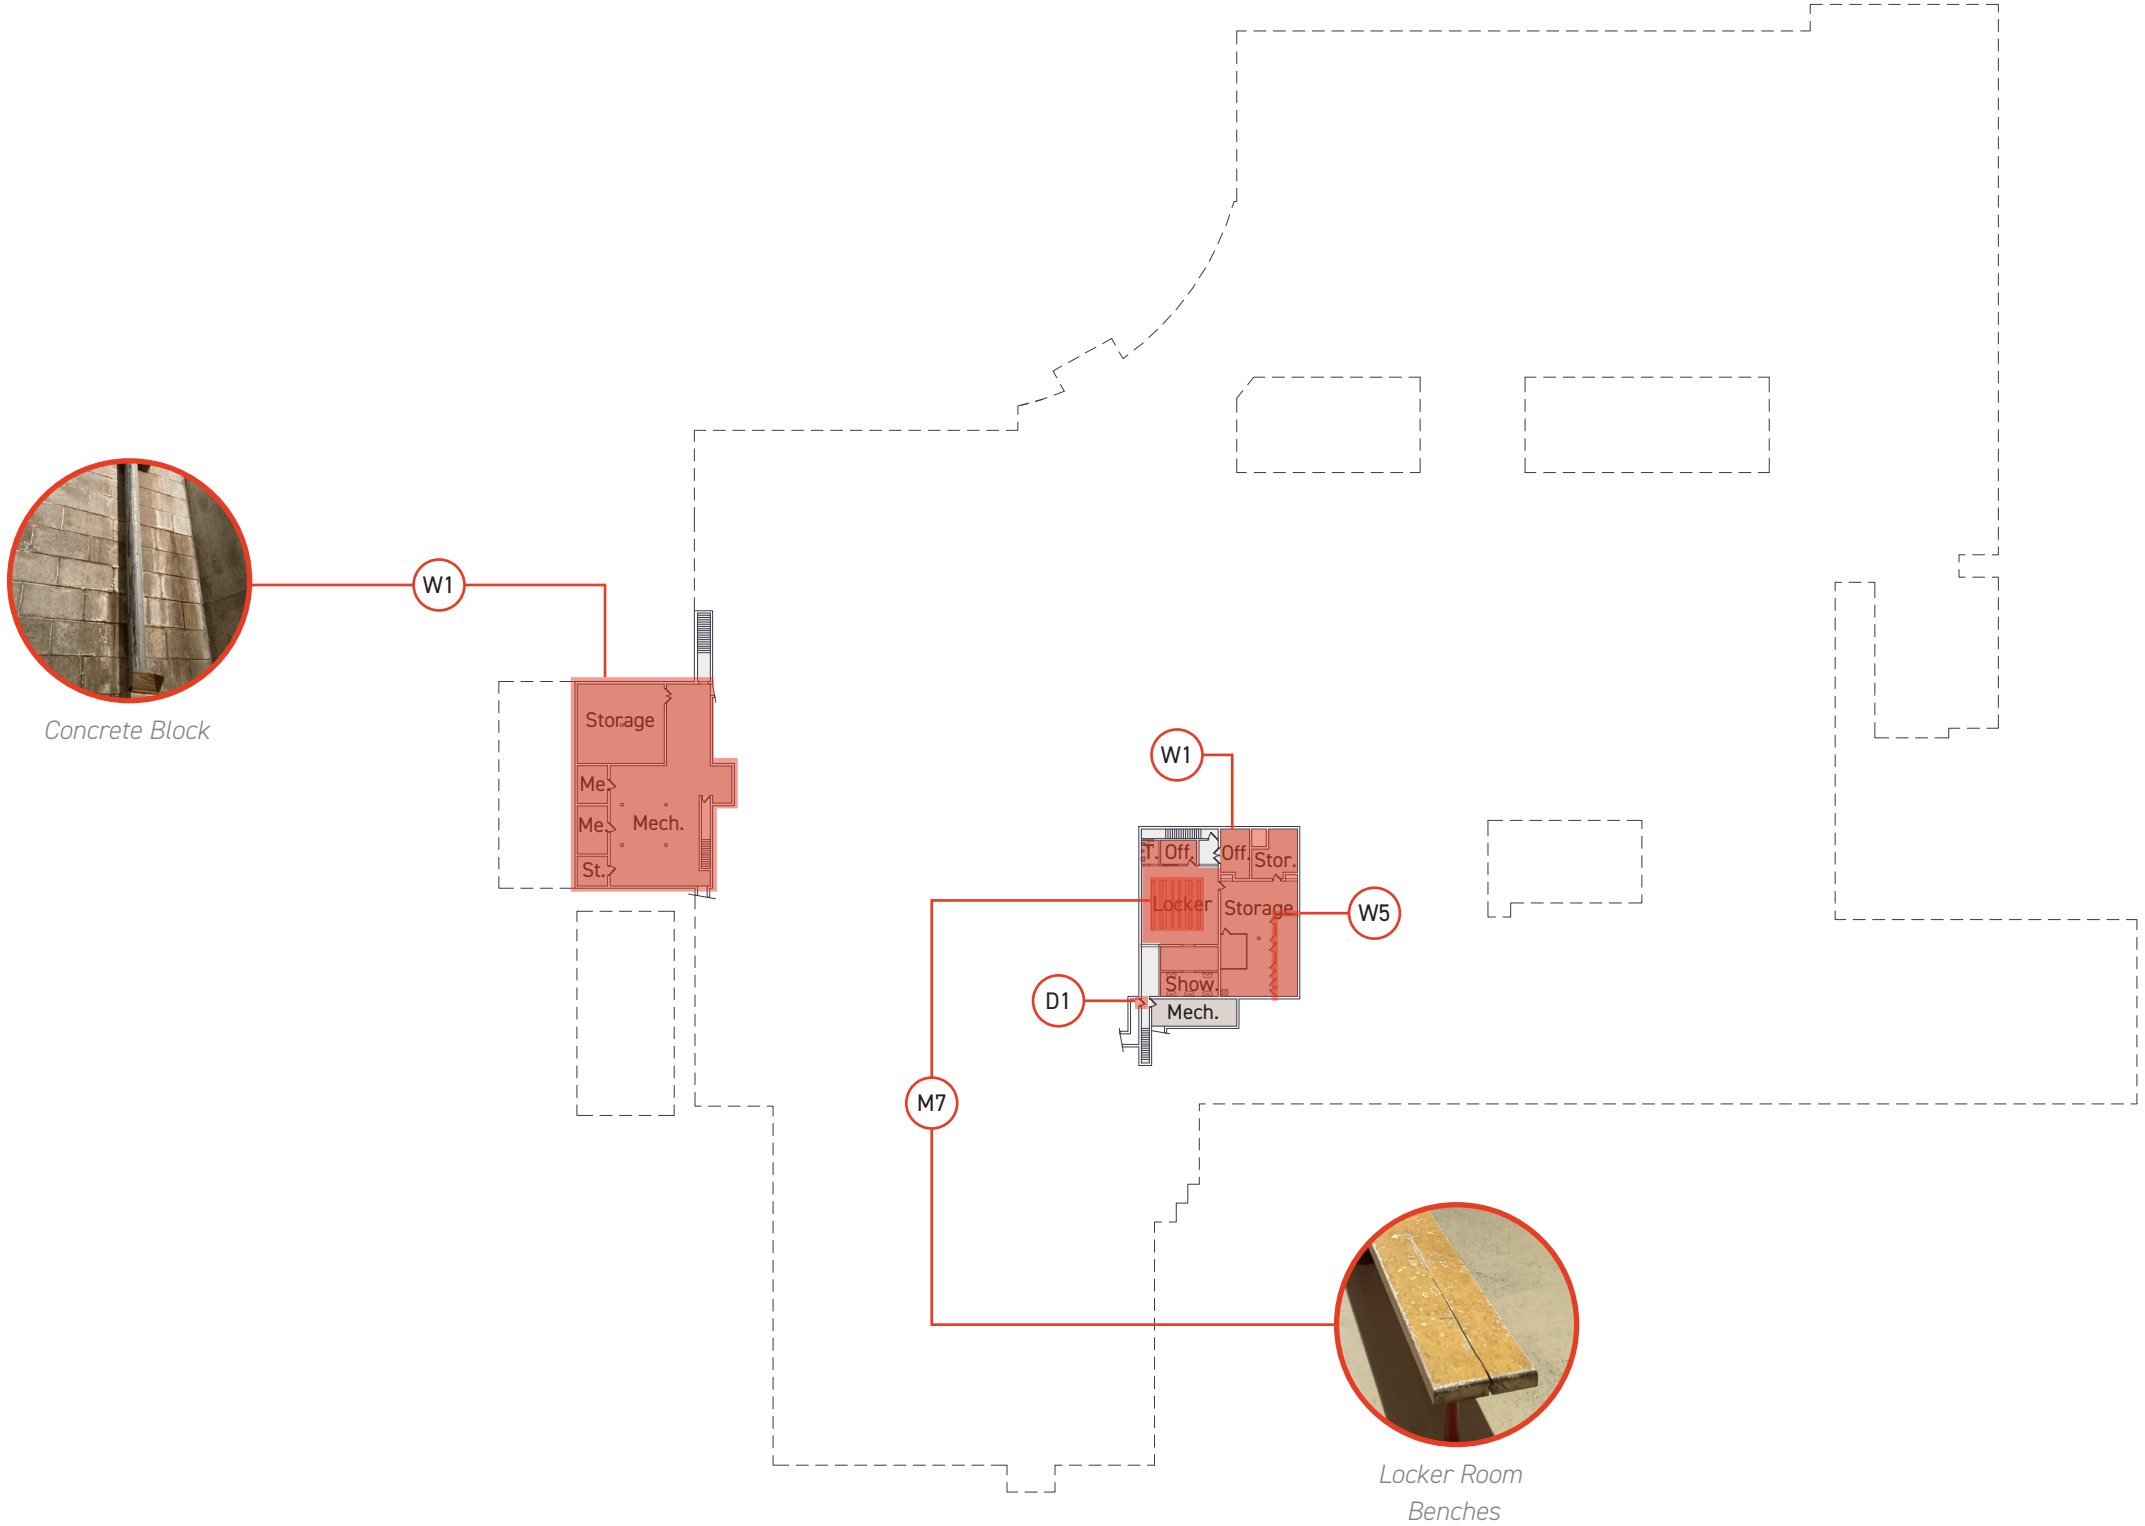
sparta high school interior identifications + analysis | first floor

- Majority of the metal lintels located in the original 1962 building are in poor condition due to rusting and staining.
- The wood doors with hollow metal frames are in fair condition overall, but there are many instances of poor condition due to scratching, denting, and fading.
- Majority of the gypsum walls located throughout the building are in fair condition, except a few instances that are in poor condition due to cracking and chipping of paint.
- There are few instances of concrete block in poor condition due to chipping, cracking, and scratching.
- The concrete block above the windows in the south portion of the 1990 addition are in poor condition due to cracking.

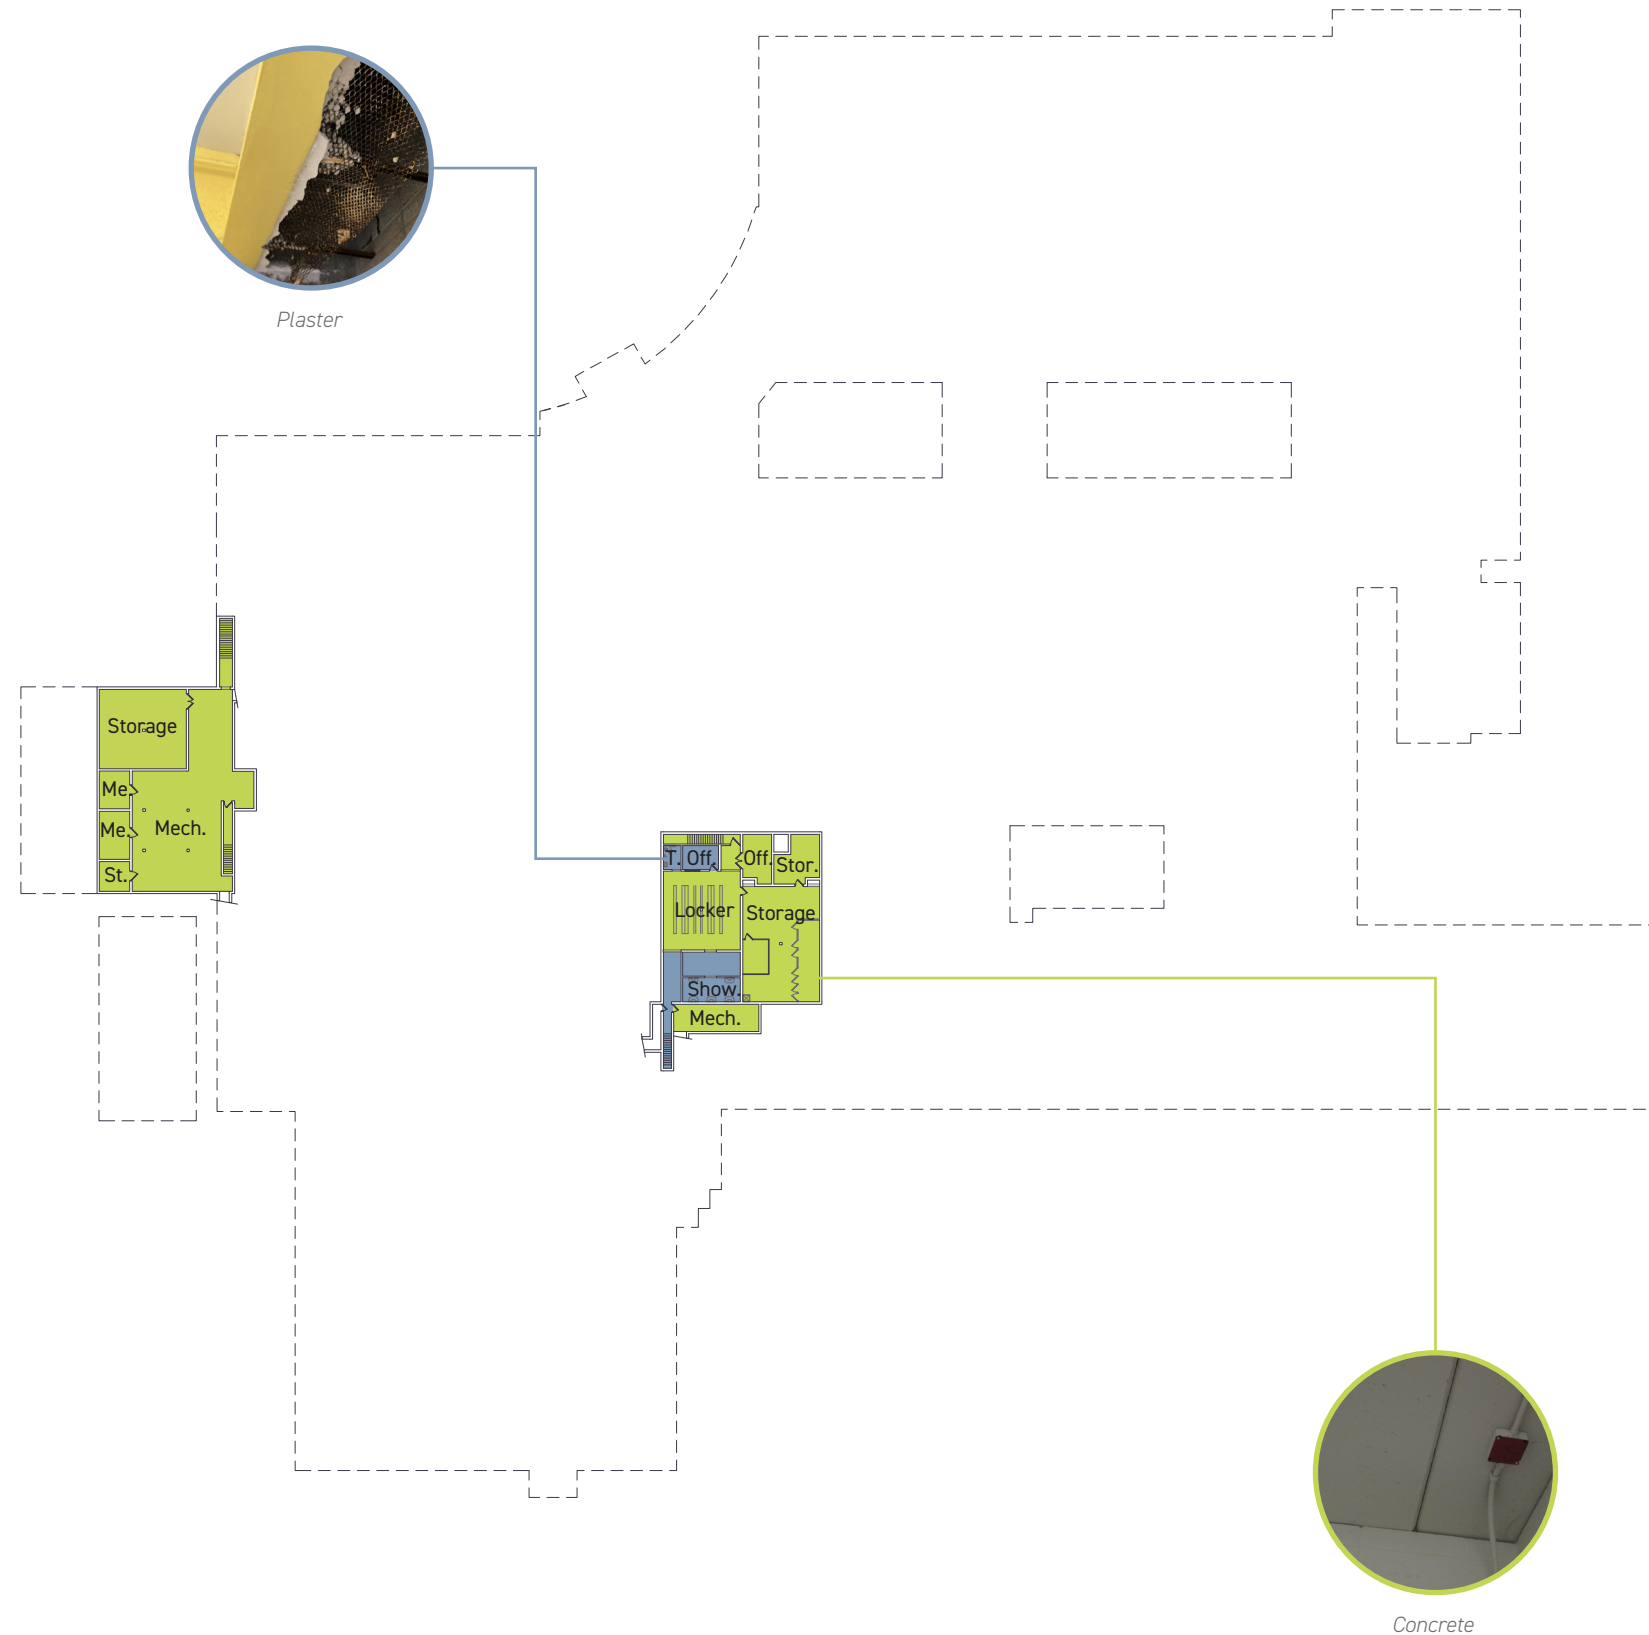
- Materials identified as potentially containing asbestos are considered to be in poor condition.
- Spline ceilings are identified as a potential asbestos containing material.
- Majority of acoustical ceiling tile located in the north side of the school are in good condition due to few instances of staining or warping.
- Majority of classrooms with concrete ceilings are in poor condition due to cracking.

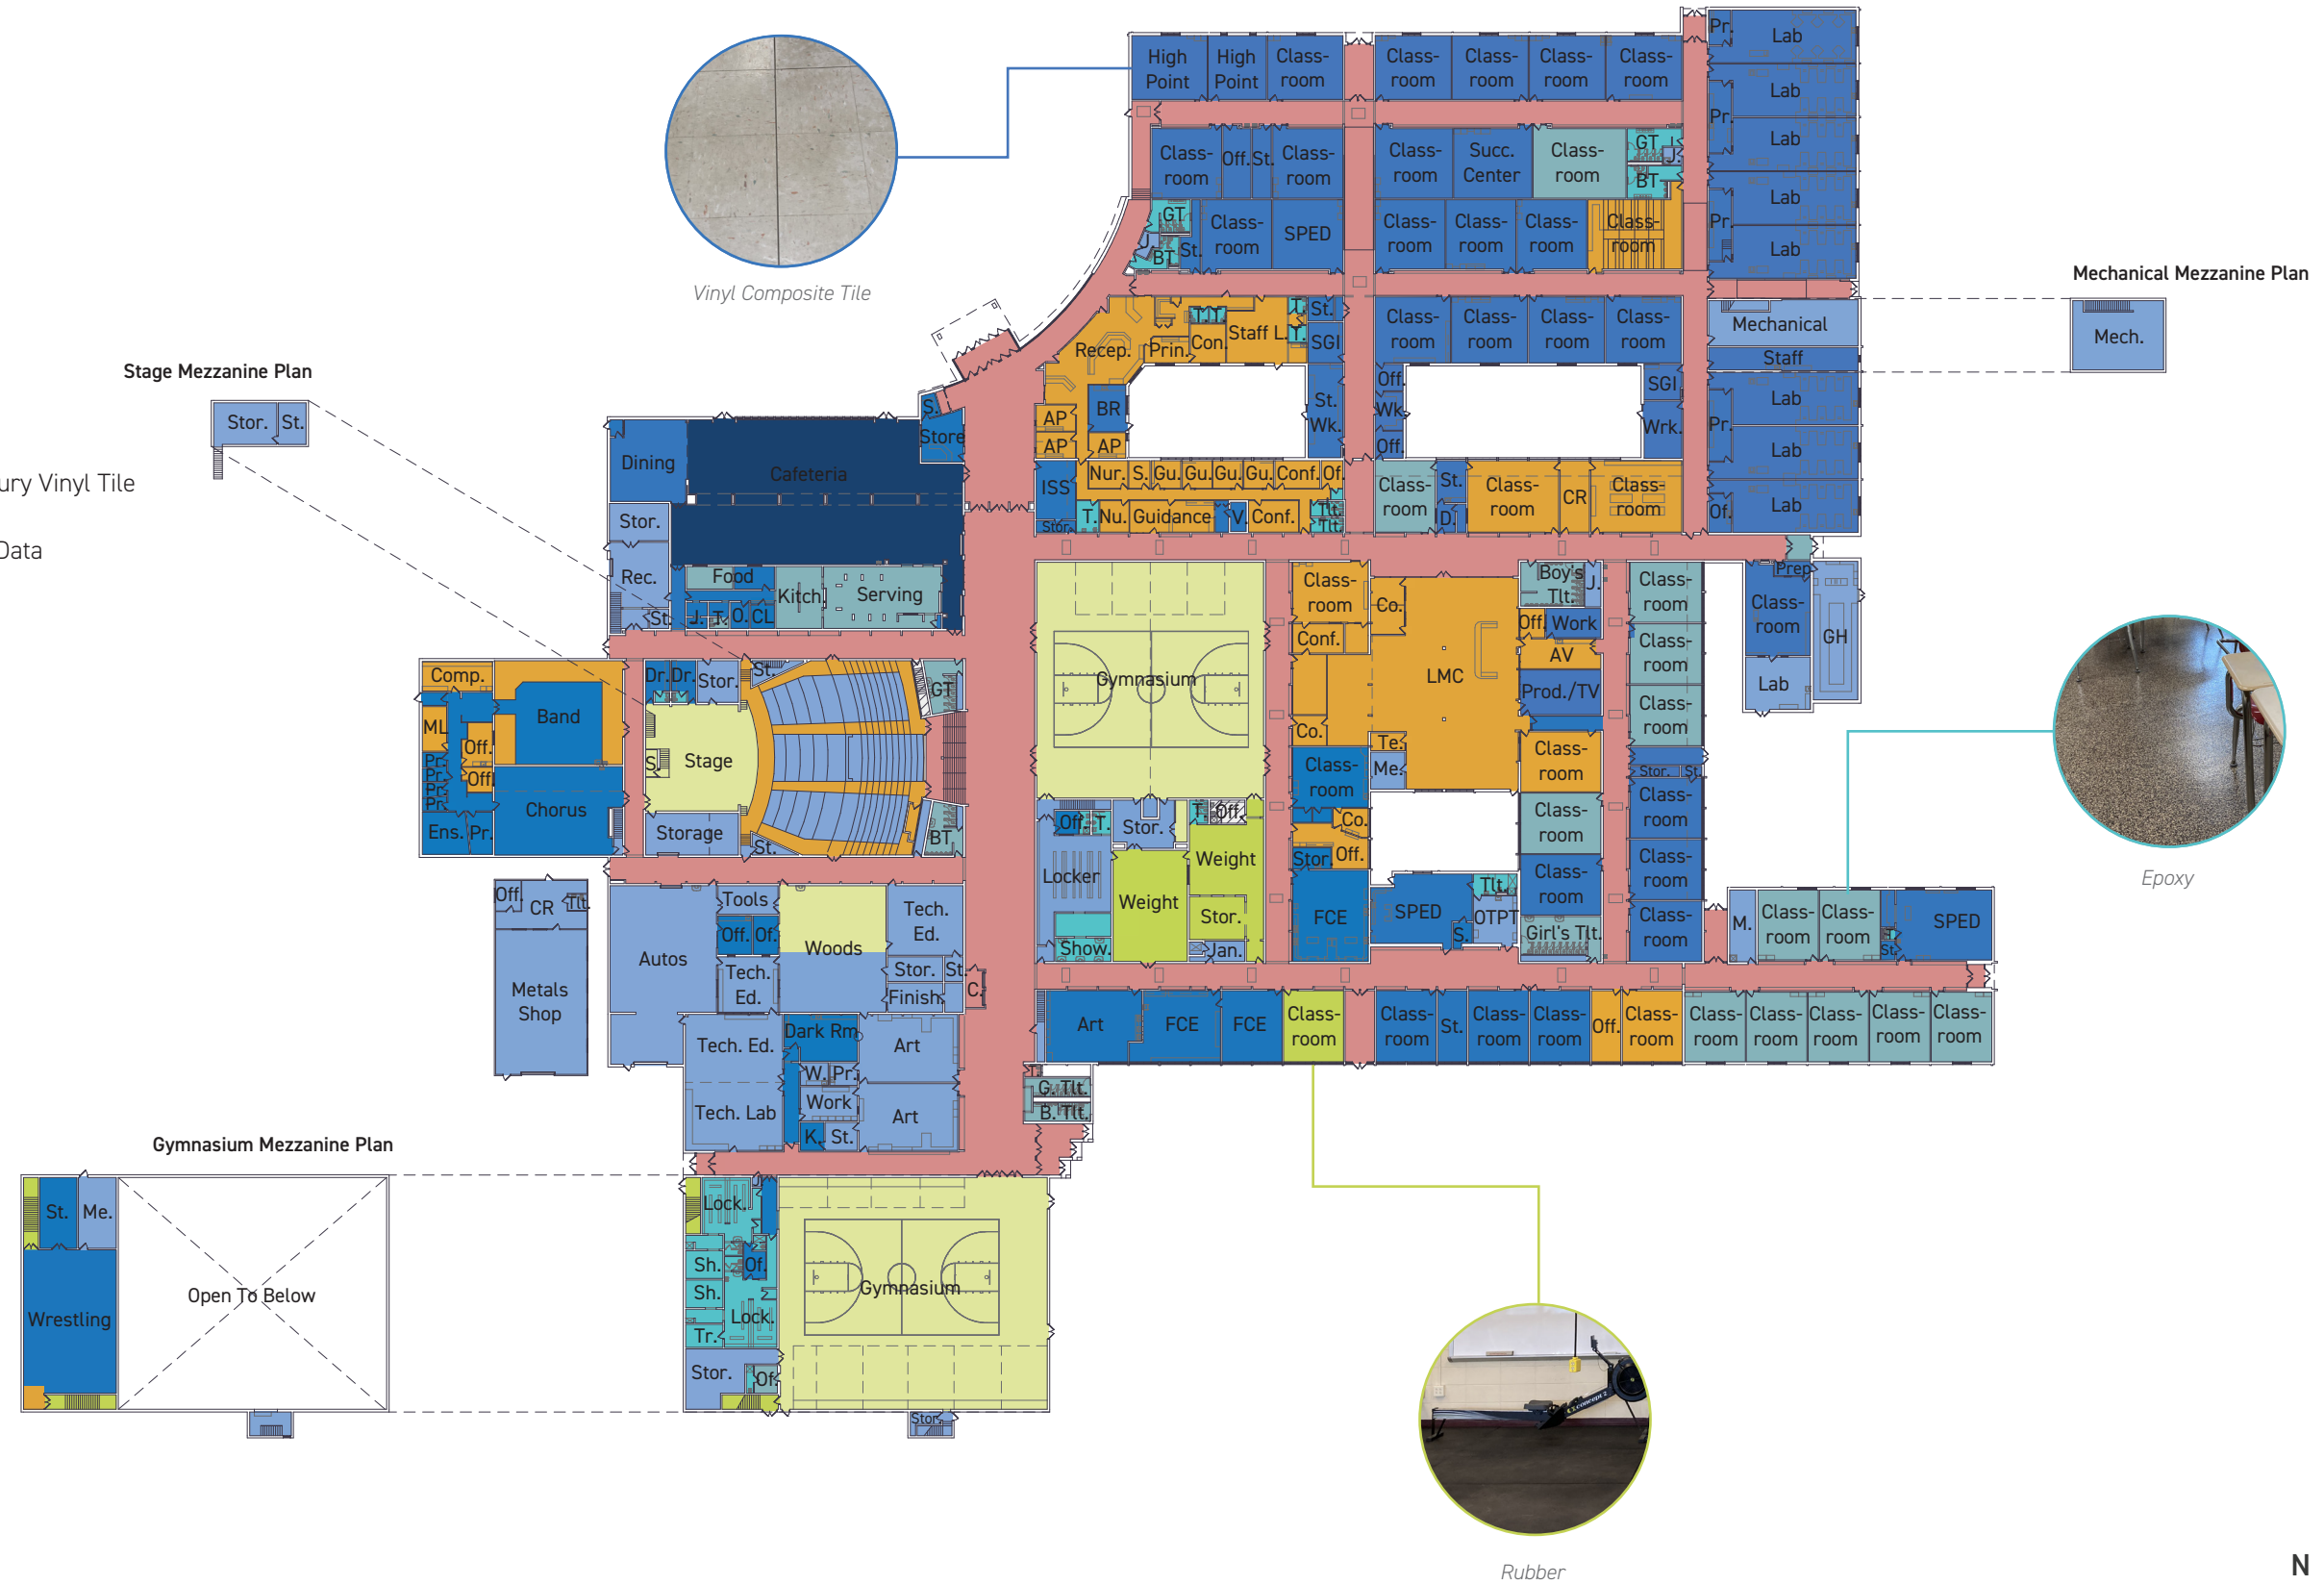
- Materials identified as potentially containing asbestos are considered to be in poor condition.
- 9" x 9" vinyl tile flooring is identified as potential asbestos tile.
- There are instances of concrete flooring located in the lower level that are in poor condition due to cracking and staining.
- Majority of VCT flooring is in fair condition due to minor scratching and wear.

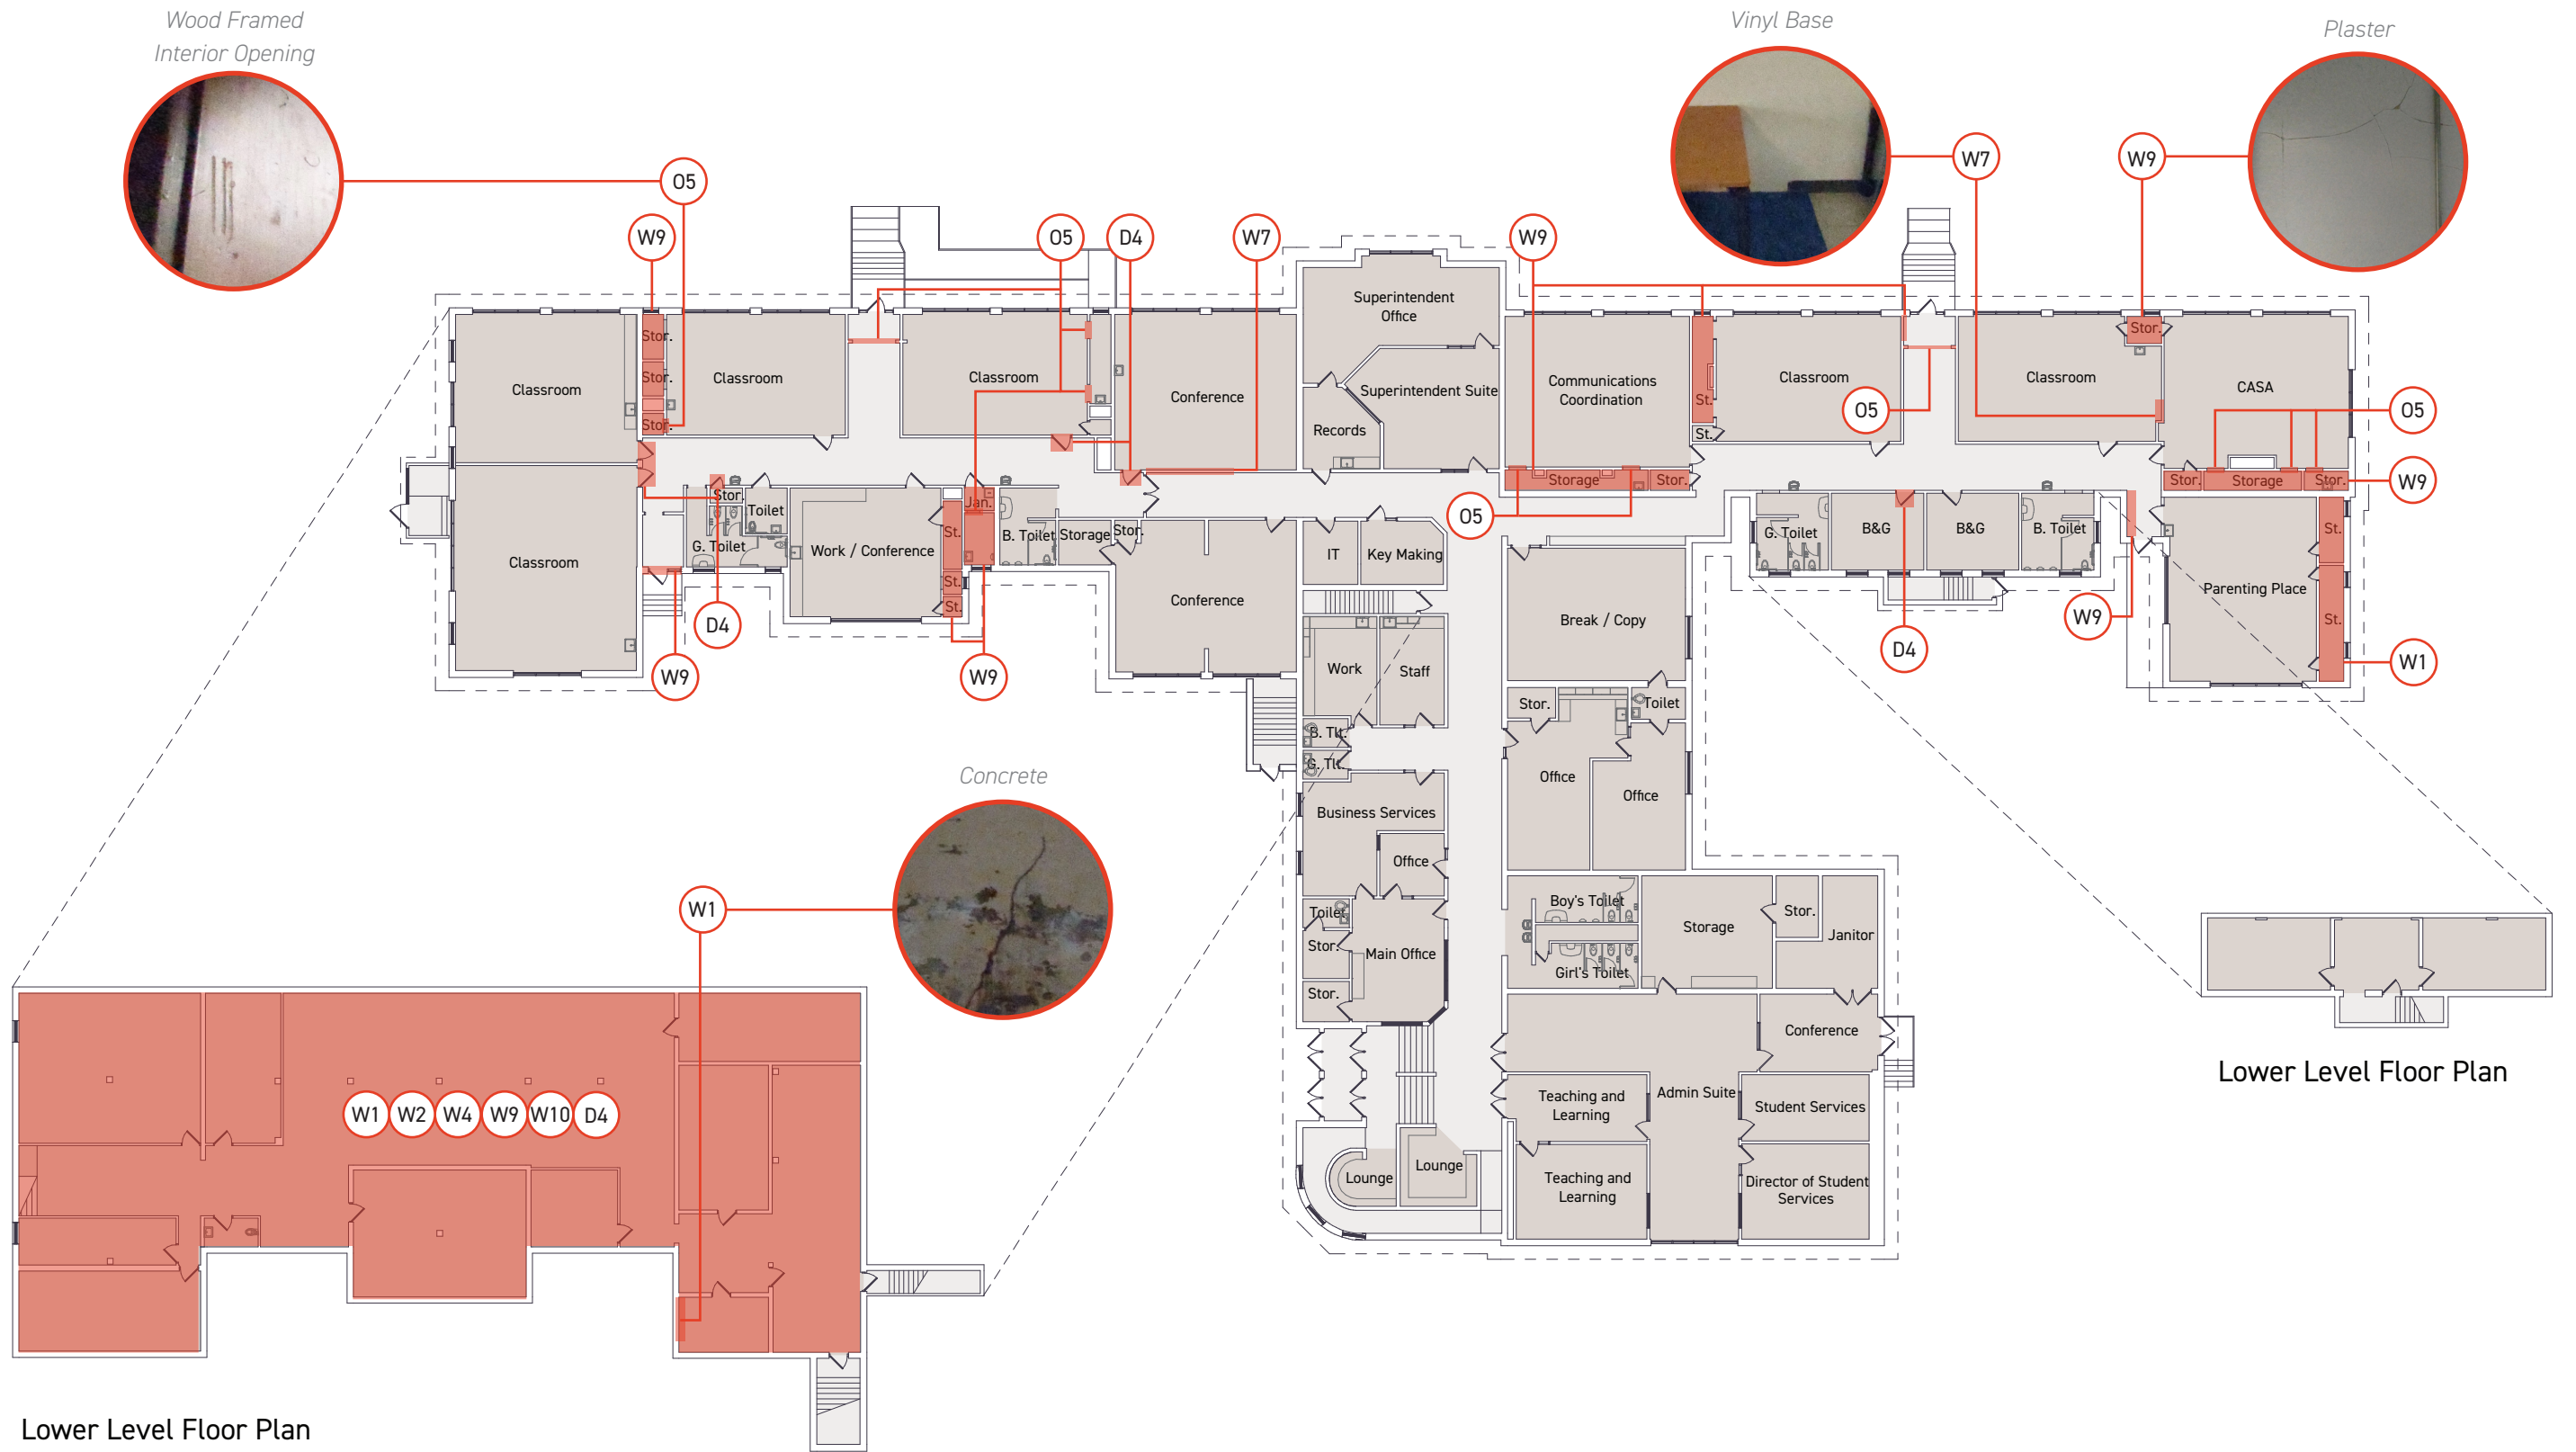
district office interior identifications + analysis | first floor

- Majority of walls and doors in the 1990 academic addition are in fair condition, due to minor scratching and denting.
- Plaster walls located in closets from the 1927 original building are in poor condition due to staining, cracking, and peeling.
- Majority of the wood framed interior openings from the 1927 original building are in fair to poor condition due to scuffing, scratching, and worn finish.
- Majority of concrete block walls and wooden doors located in the southern lower level are in poor condition due to staining and cracking. Wood panel walls are in fair condition due to minor scratching and worn finish.

***Note:** The diagram above reflects instances of materials in poor condition, but does not reflect the material's overall condition.

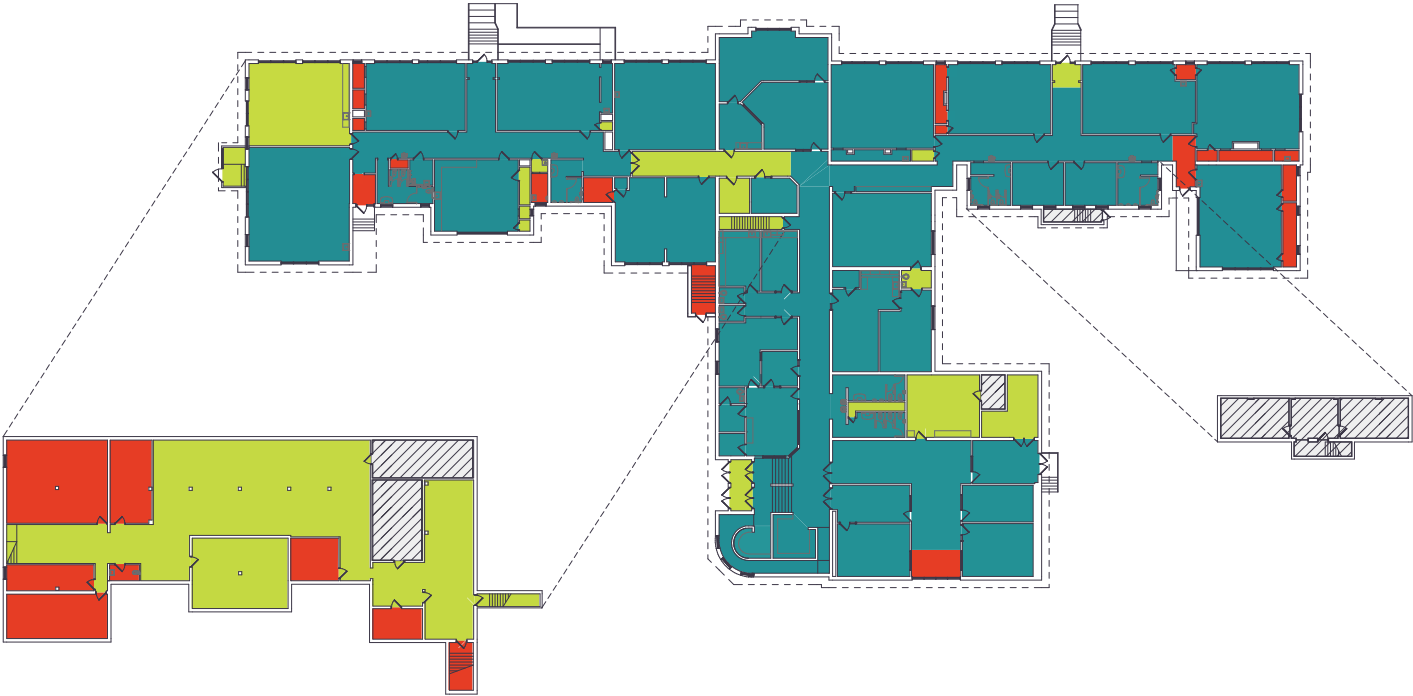
district office ceiling analysis

- Materials identified as potentially containing asbestos are considered to be in poor condition.
- Spline ceilings are identified as a potential asbestos containing material.
- There are some instances of acoustical ceiling tile in poor condition due to staining and warping.
- Majority of plaster ceilings located in closets are in poor condition due to cracking, staining, and peeling.

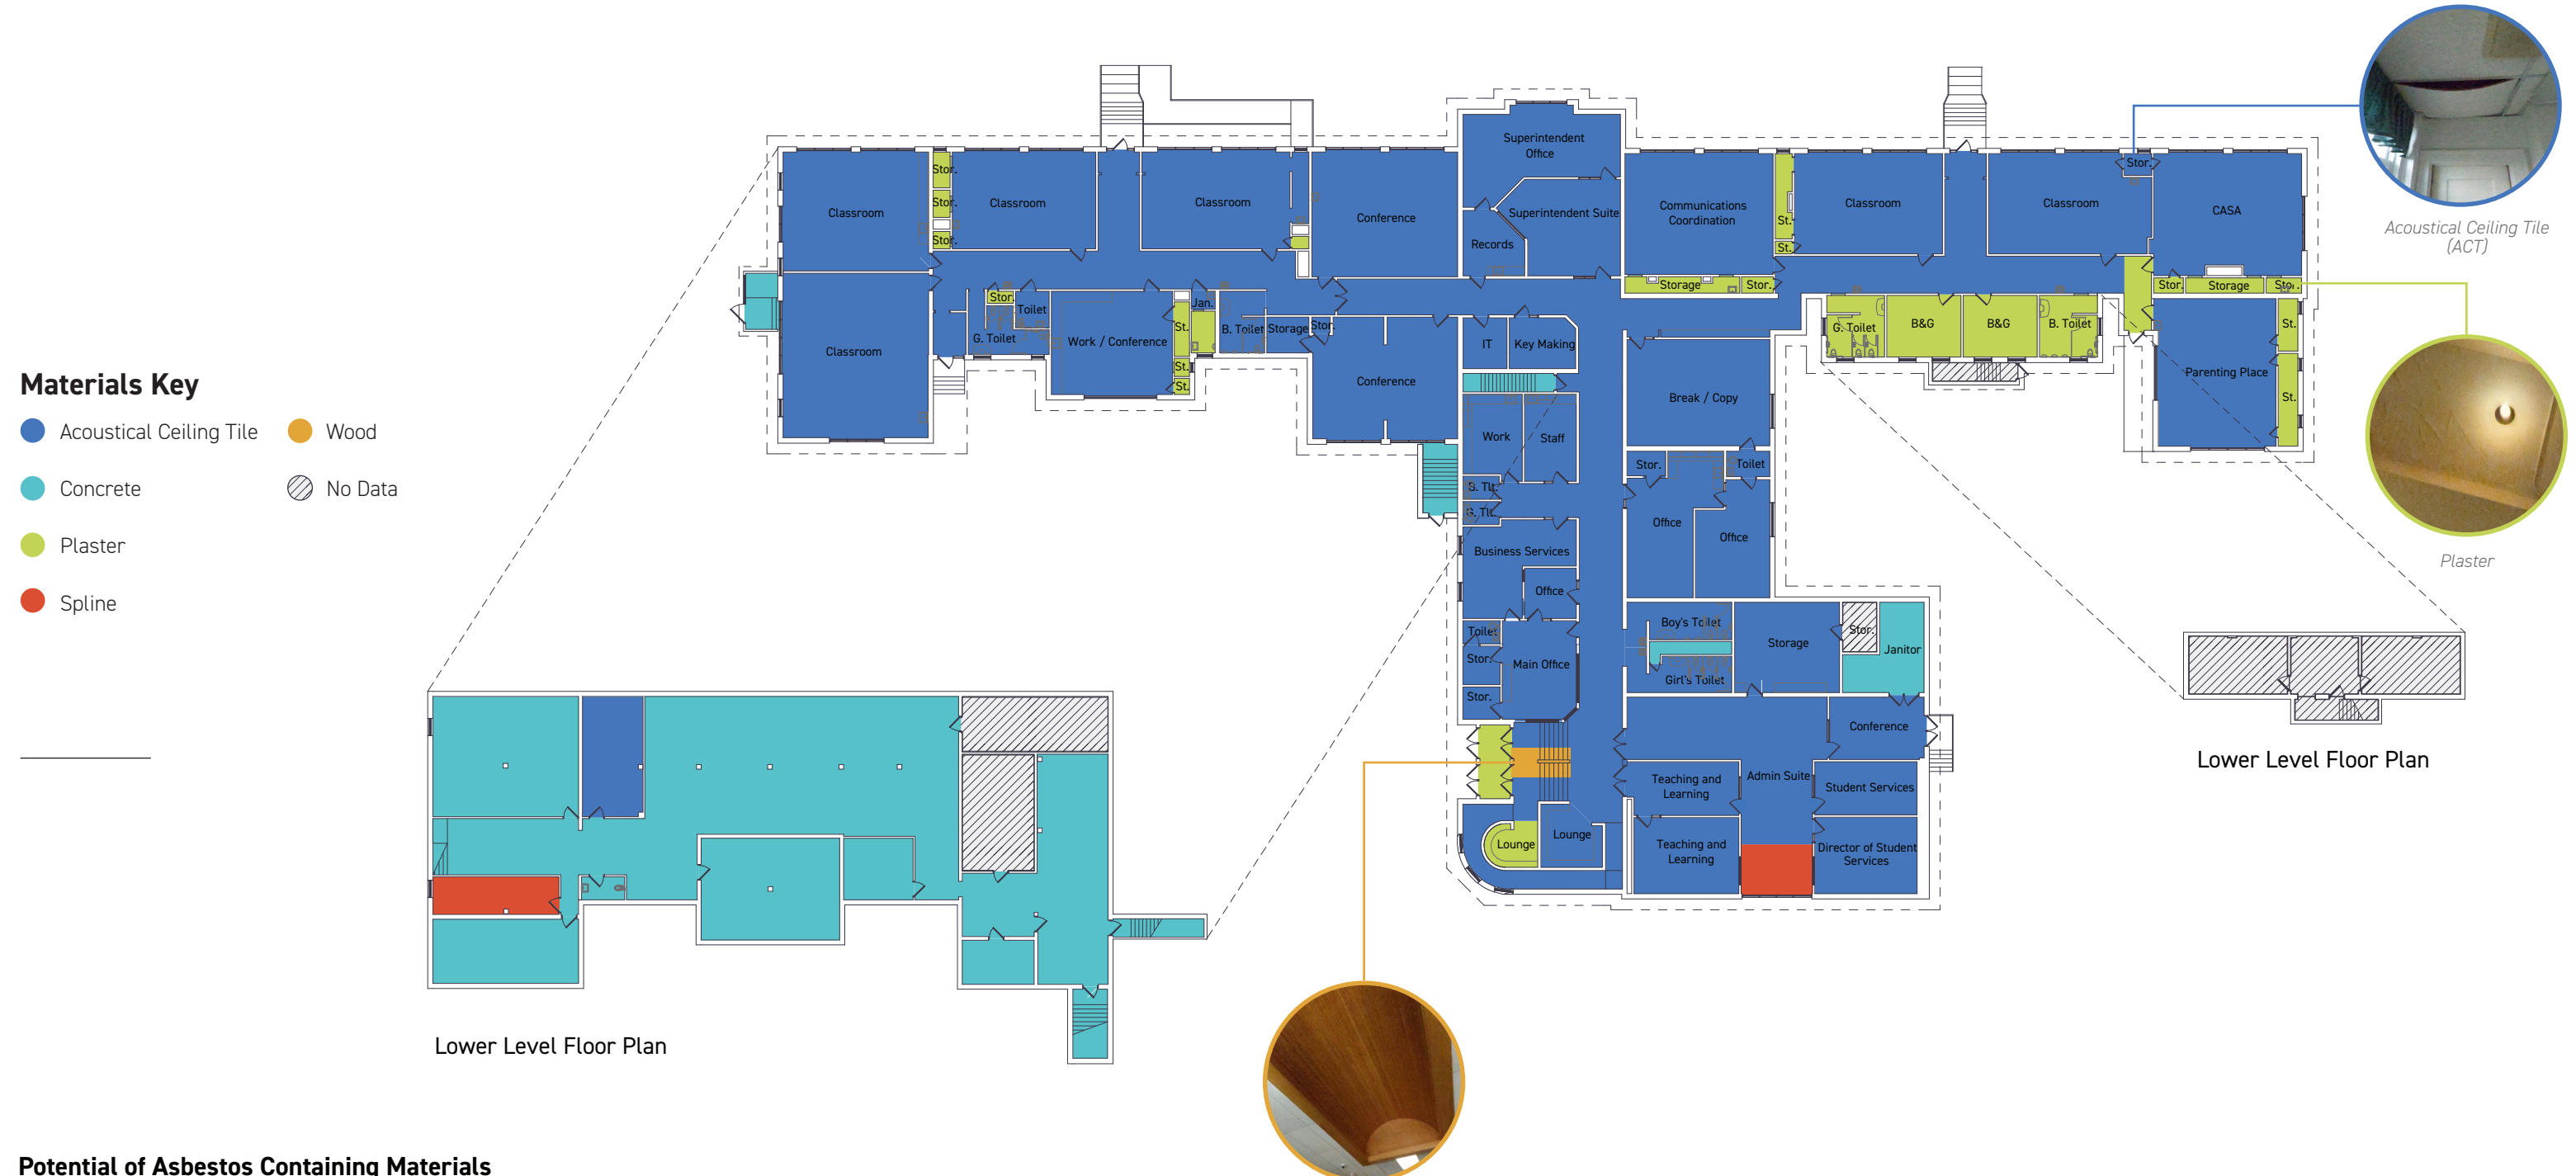
district office ceiling material identification

Asbestos is a material that was used in the construction industry, most commonly between 1960 - 1990. **There was no asbestos testing performed for this assessment.** Observations and assumptions were made based on common older building materials that typically have been identified to containing asbestos.

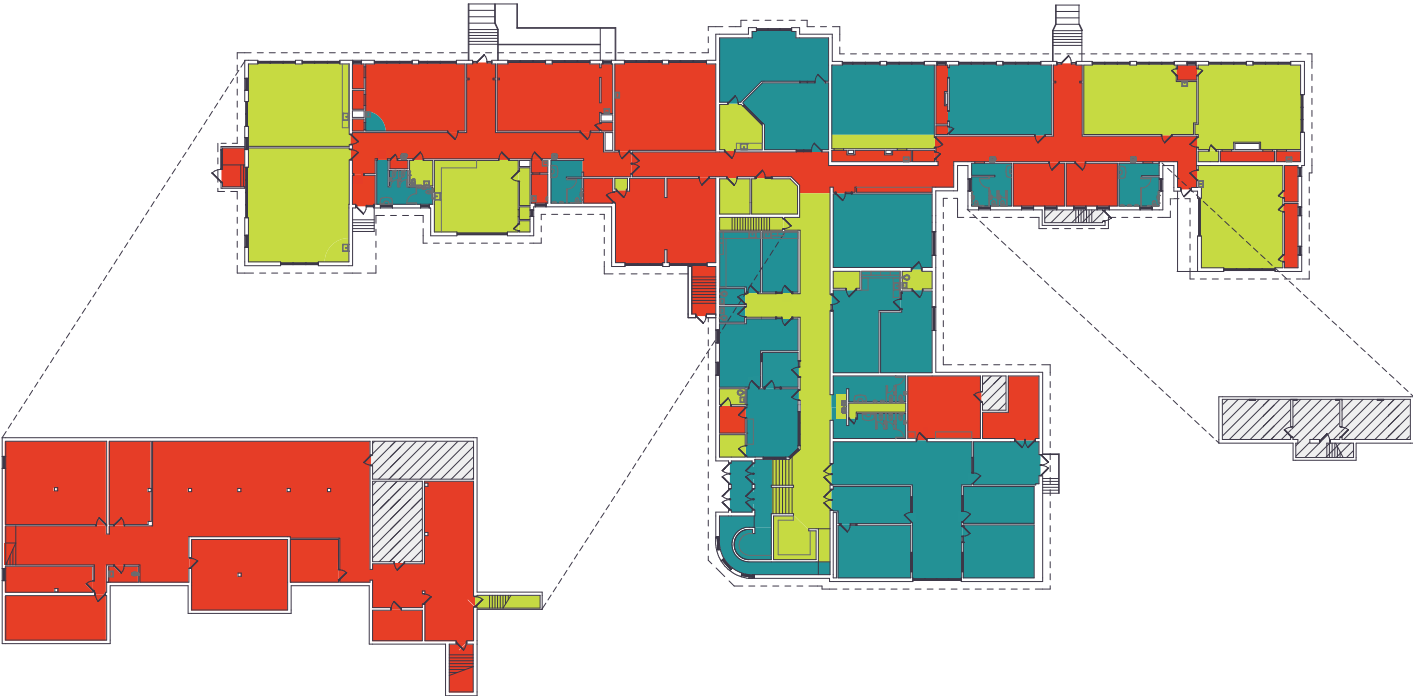
district office flooring analysis

- Materials identified as potentially containing asbestos are considered to be in poor condition.
- Carpet flooring located in classrooms is in poor condition due to staining and wearing.
- Terrazzo flooring located in hallways and restrooms are in poor condition due to cracking and staining.
- Concrete flooring located in the janitor's room is in poor condition due to cracking, crumbling, and staining.

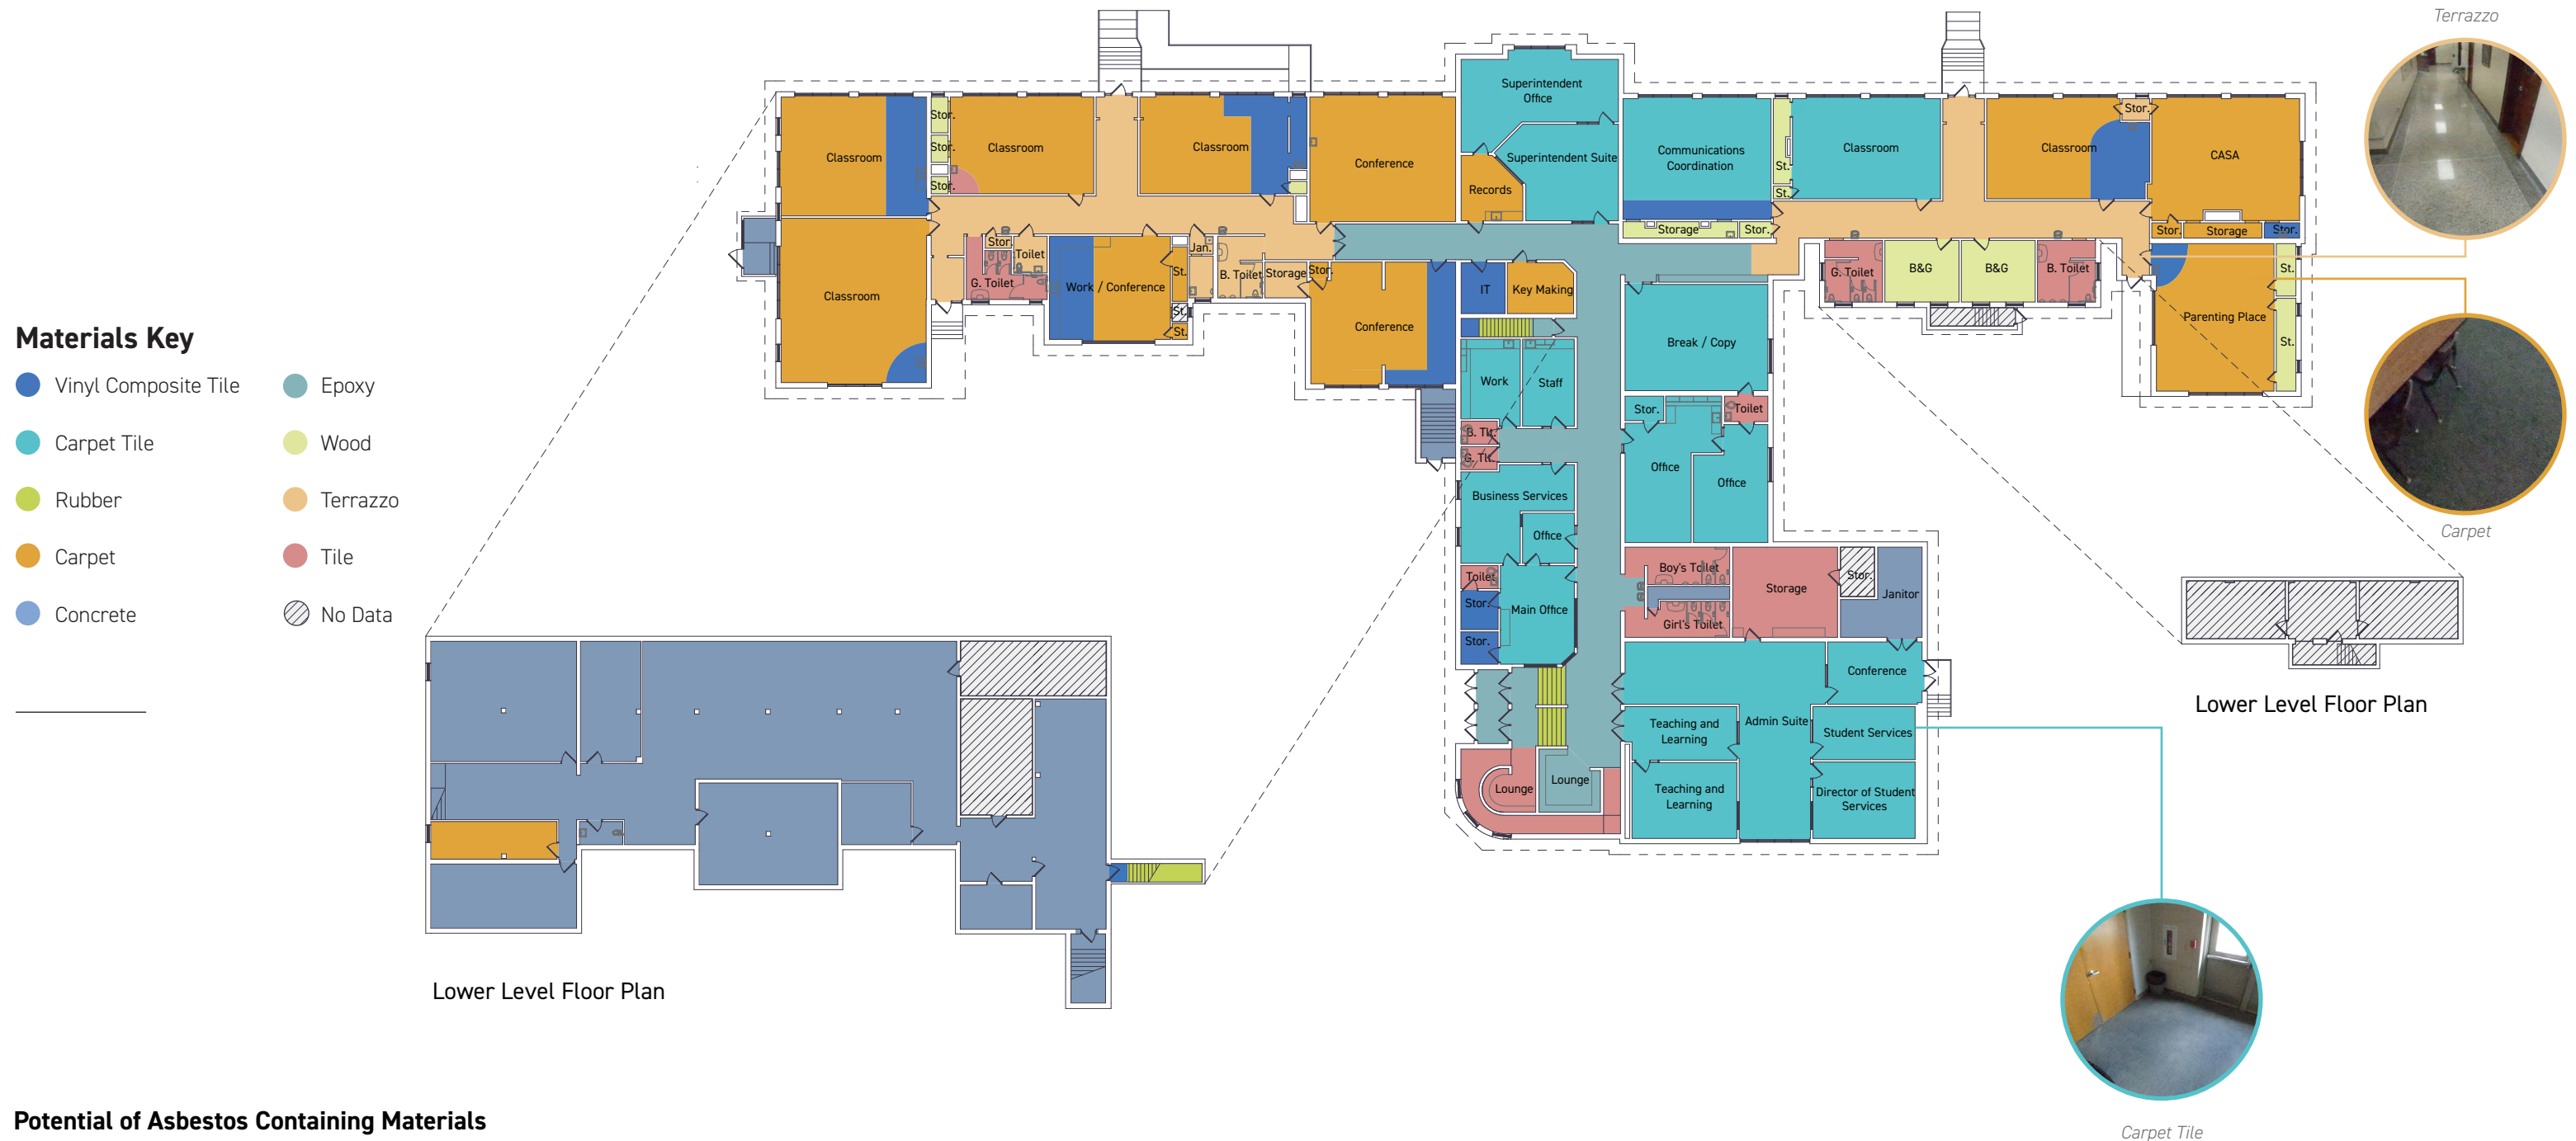
district office flooring material identification

Asbestos is a material that was used in the construction industry, most commonly between 1960 - 1990. **There was no asbestos testing performed for this assessment.** Observations and assumptions were made based on common older building materials that typically have been identified to containing asbestos.
