BRAYARCHITECTS

contents

sparta high school building systems summary

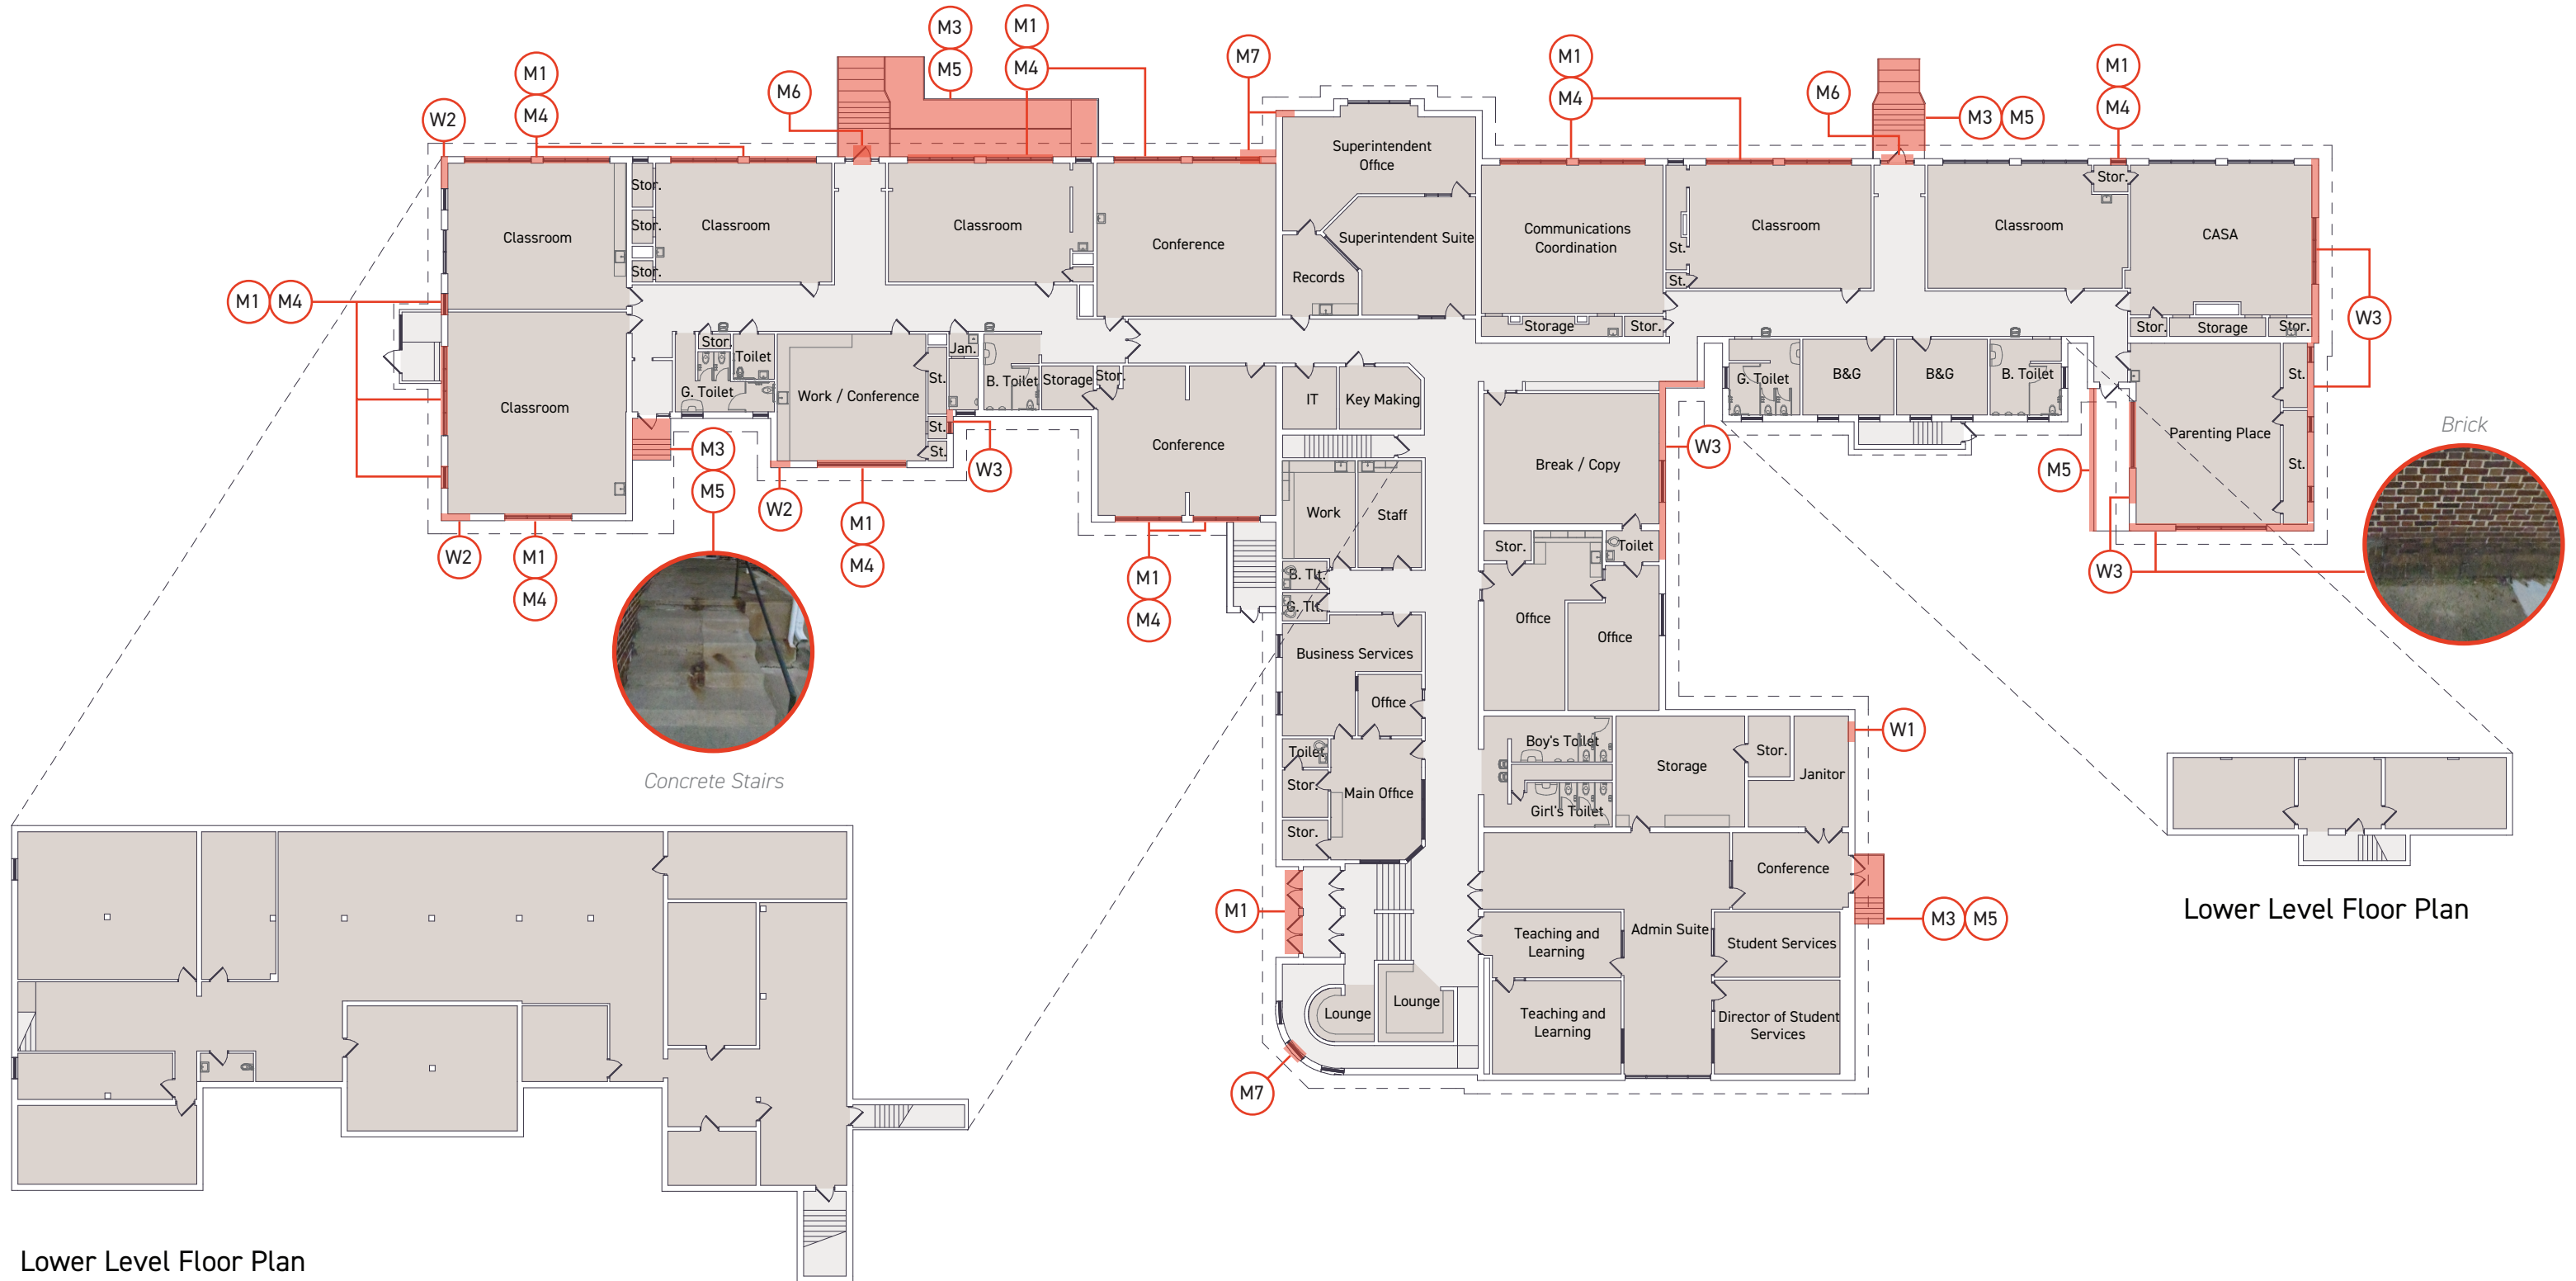
district office exterior identifications + analysis

***Note:** The diagram above reflects instances of materials in poor condition, but does not reflect the material's overall condition.

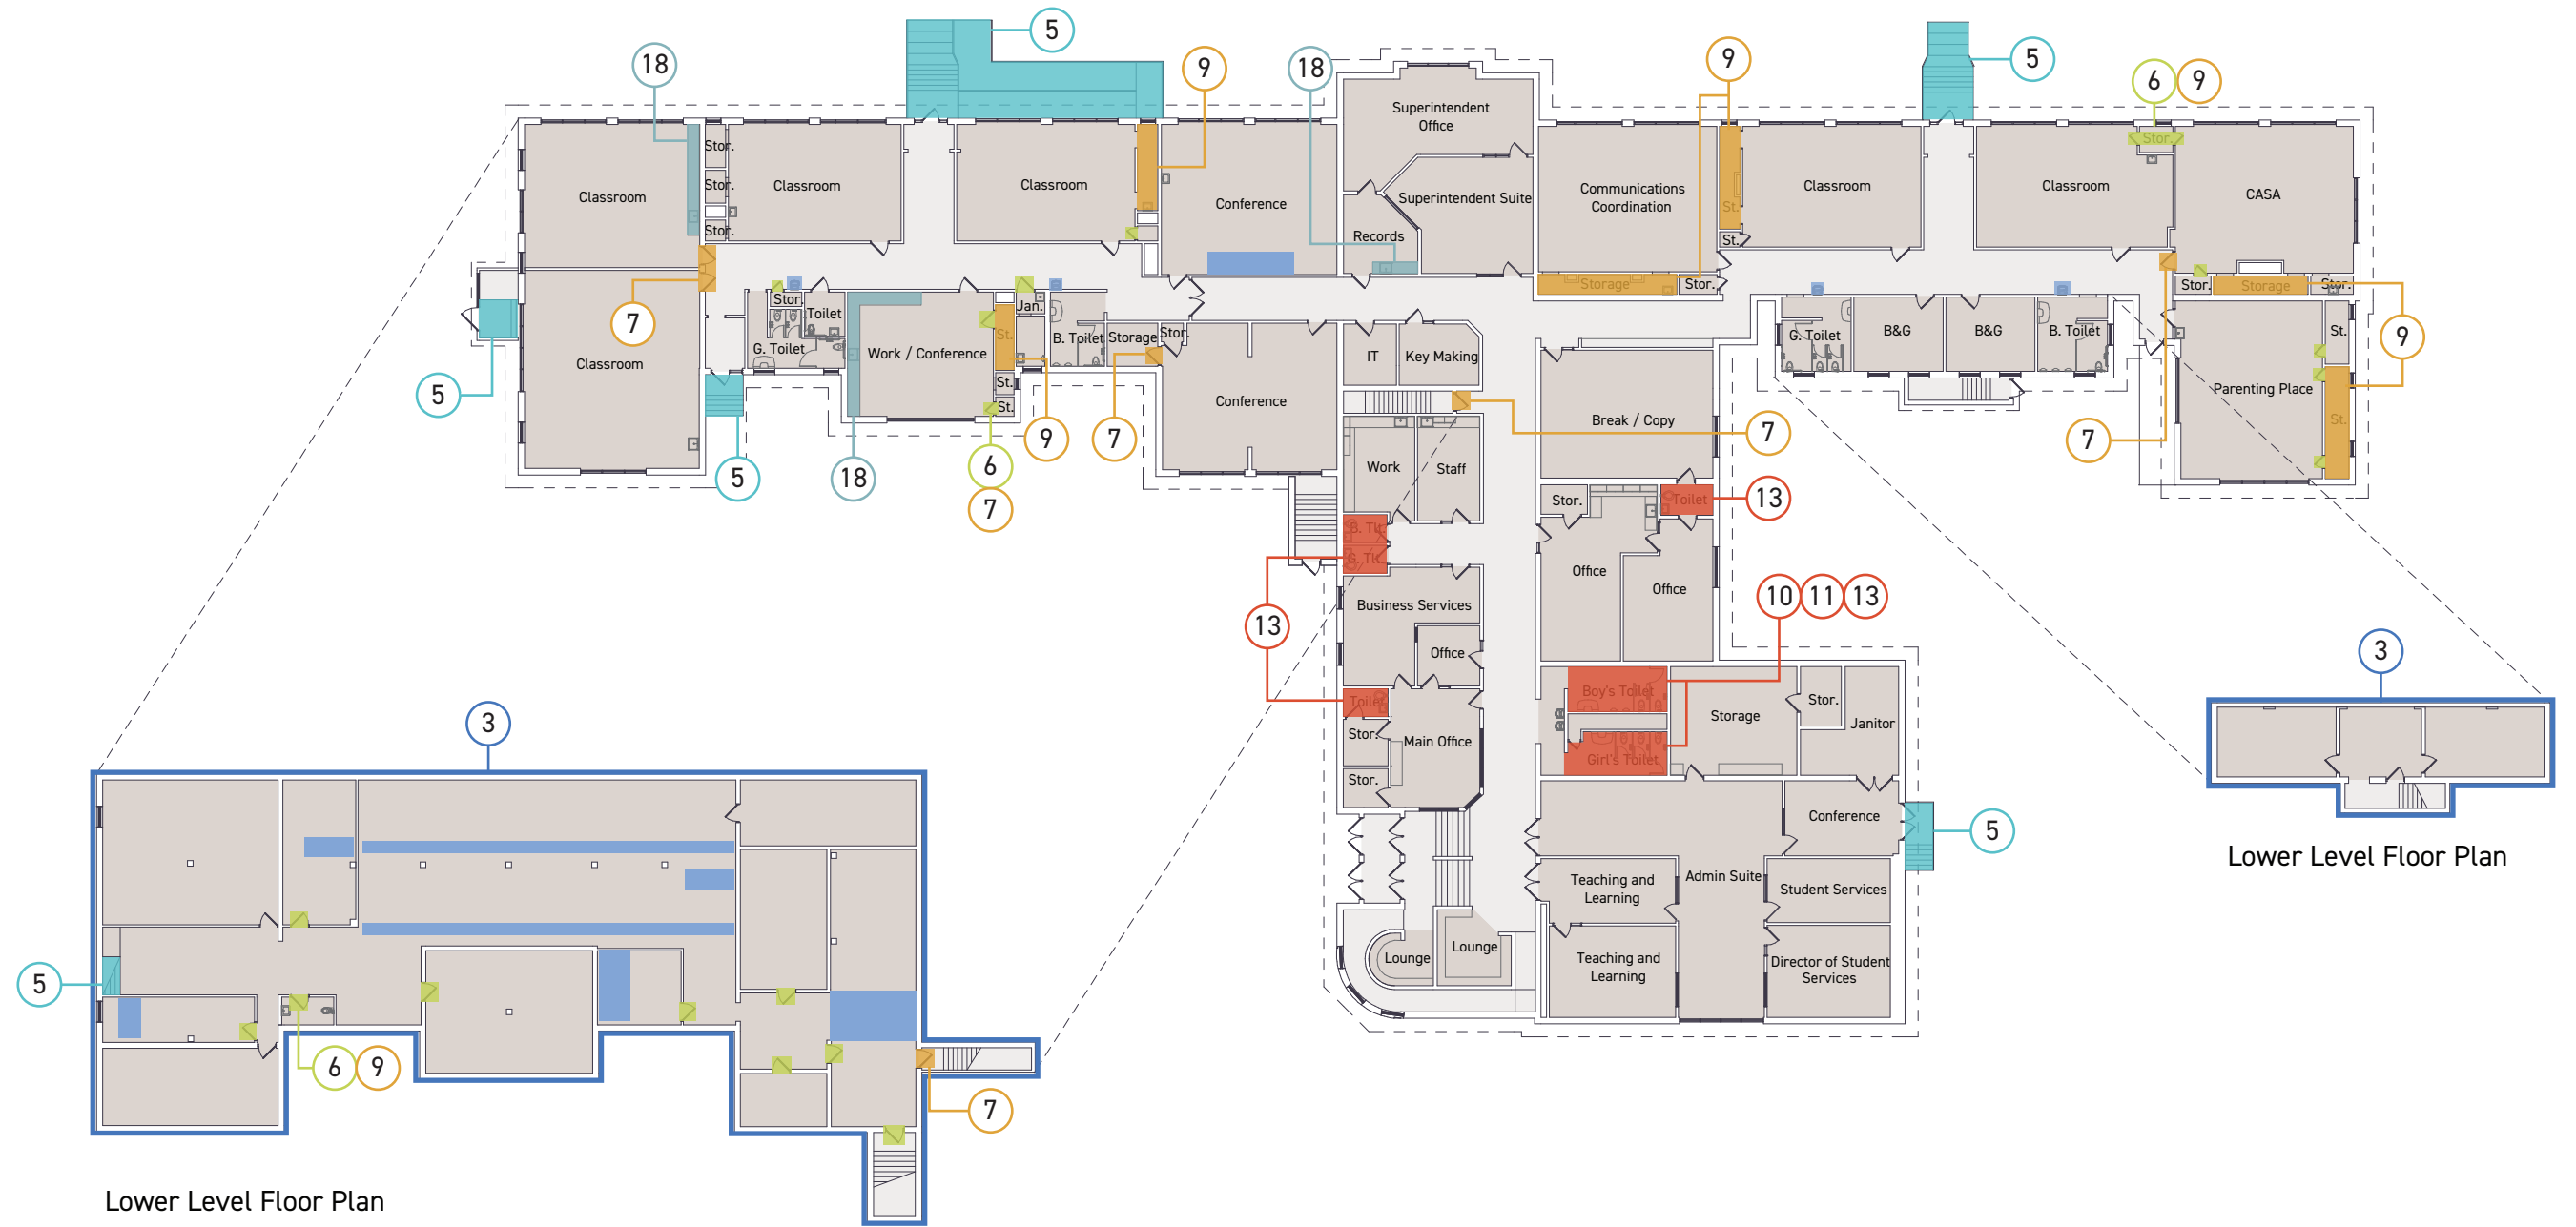
district office ada conditions + assessment | first floor

- Domestic water system
- Sanitary system
- Interior wall and door repair at select/identified areas
- Ceiling replacement at select/identified areas
- Flooring replacement at select/identified areas
- Exterior doors at identified areas
- Exterior windows at identified area
- Potential asbestos remediation
- ADA improvements at identified areas
- Exterior wall repair at select/identified areas

- Storm system
- Plumbing equipment and fixtures
- HVAC control systems
- Electrical service and panelboards
- Wiring devices
- Emergency egress lighting
- Public address system
- Ceiling replacement at select/identified areas
- Flooring replacement at select/identified areas
- Exterior doors at identified areas
- Exterior windows at identified area
