Sparta Area School District

District-wide Facilities Study

DRAFT

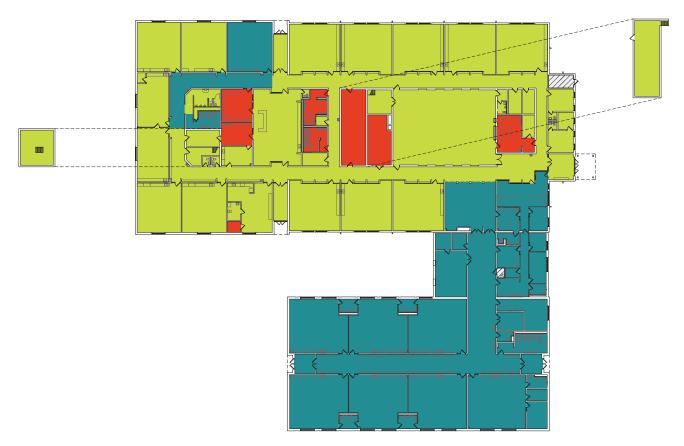
First Floor

- Materials identified as potentially containing asbestos are considered to be in poor condition.
- Spline ceilings are identified as a potential asbestos containing material.
- Most concrete ceilings are in fair condition due to minor cracking.

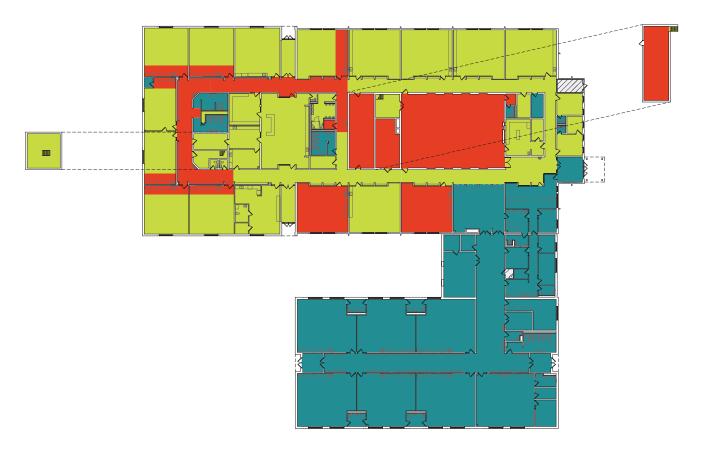
First Floor

- Materials identified as potentially containing asbestos are considered to be in poor condition.
- Majority of the flooring located in the 1965 and 1990 addition are in fair or poor condition.
- There are no instances of tile flooring in poor condition.
- Concrete flooring located in the boiler room is in poor condition due to staining, cracking, and scratching.

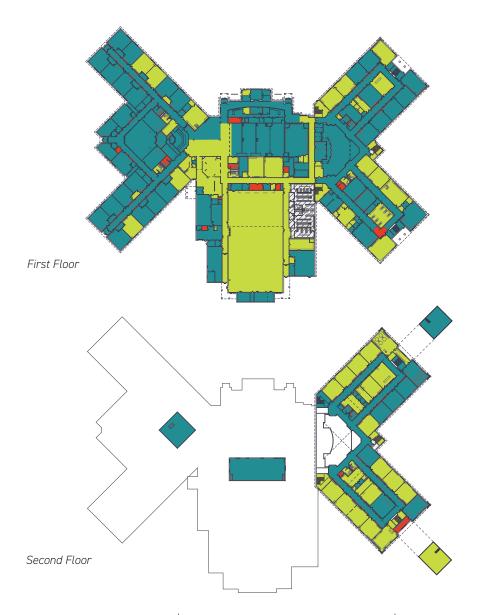
- Materials identified as potentially containing asbestos are considered to be in poor condition.
- Spline ceilings are identified as a potential asbestos containing material.
- Majority of acoustical ceiling tile is in fair condition due to minor staining and cracking.
- Concrete ceiling located in the gymnasium is in fair condition due to some cracking and wearing.

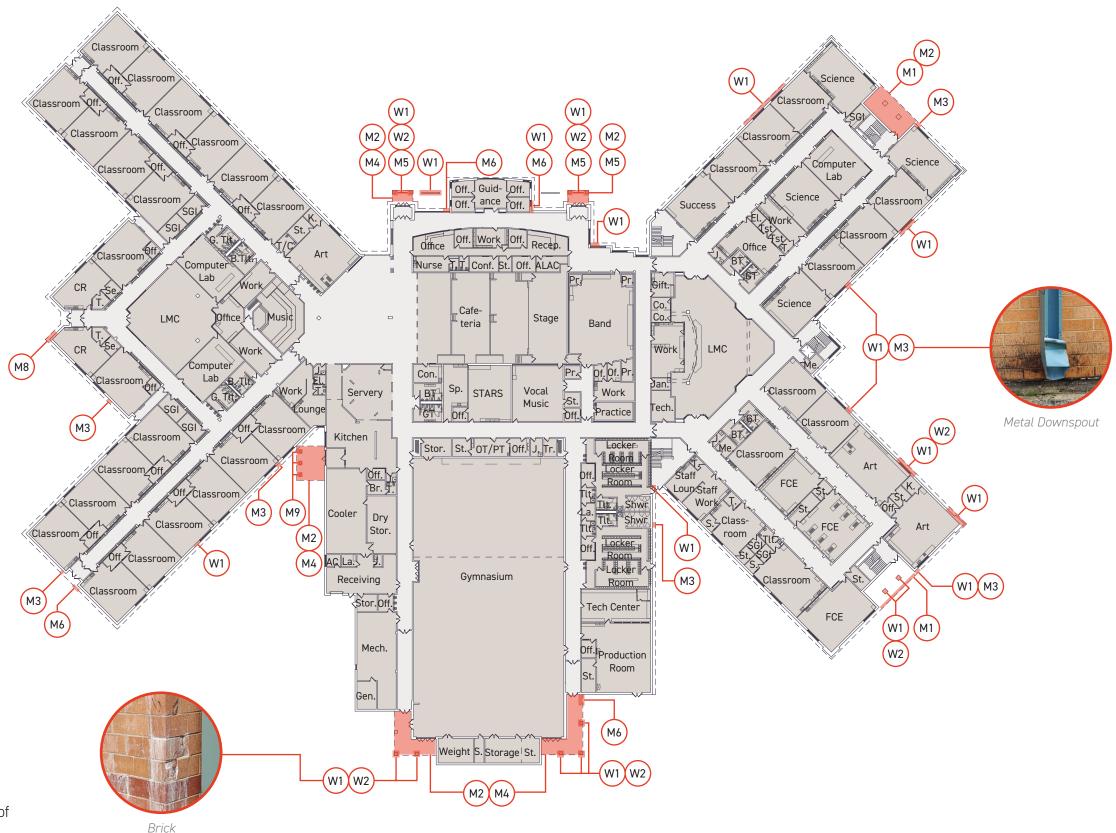
meadowview middle school exterior identifications + analysis

- · Majority of metal downspouts are in poor condition due to denting and staining.
- · Metal flashing located under brick walls is in poor condition due to many instances of denting and peeling sealant.
- There are some instances of brick in poor condition due to staining and crumbling.
- · Majority of hollow metal structure is in poor condition due to rusting and worn paint.

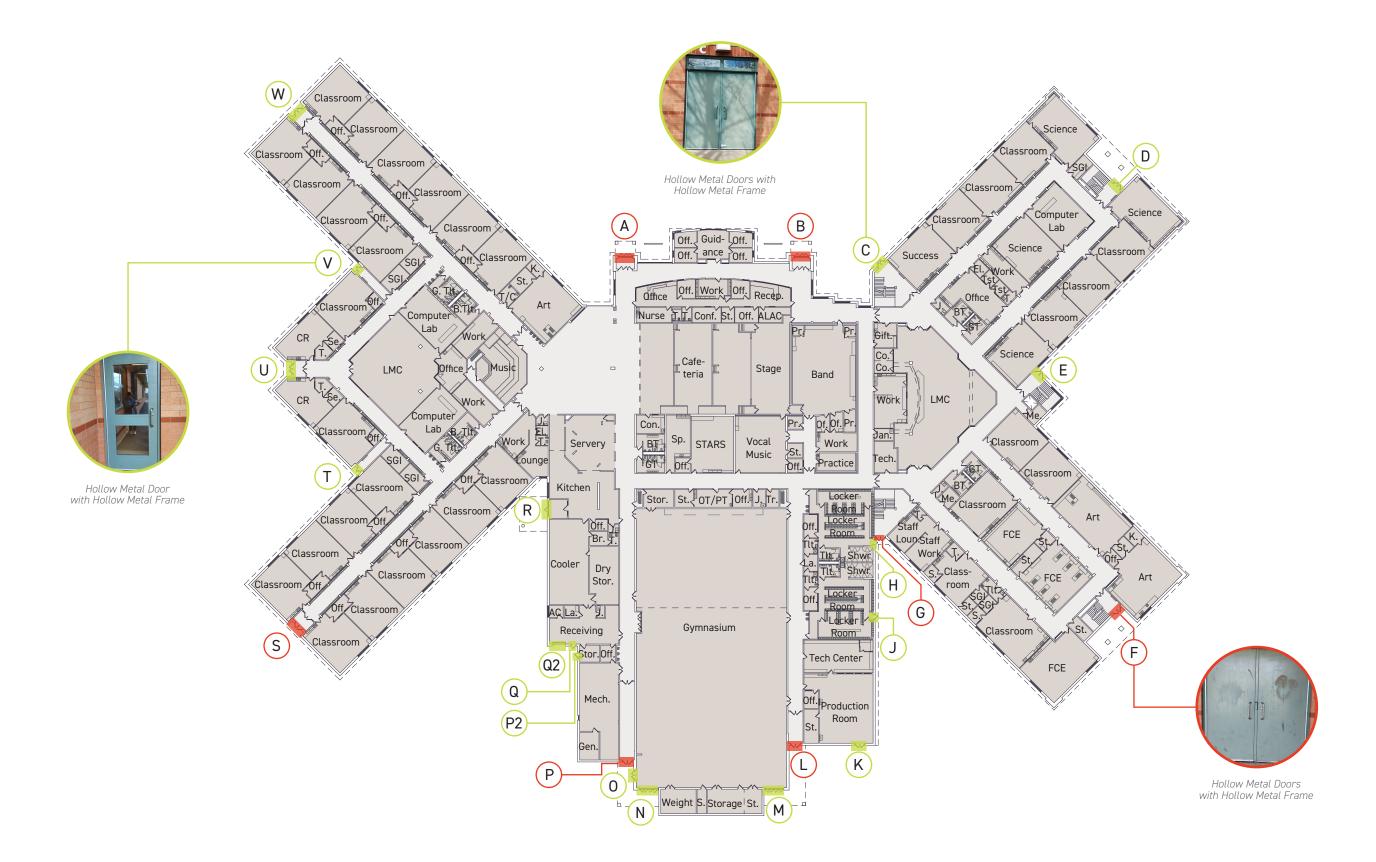
meadowview middle school exterior door identification + analysis

- There are instance of hollow metal doors in poor condition due to chipping paint, fading, and rusting.
- Majority of hollow metal doors with hollow metal frames are in fair condition due to paint scratching and/or fading.

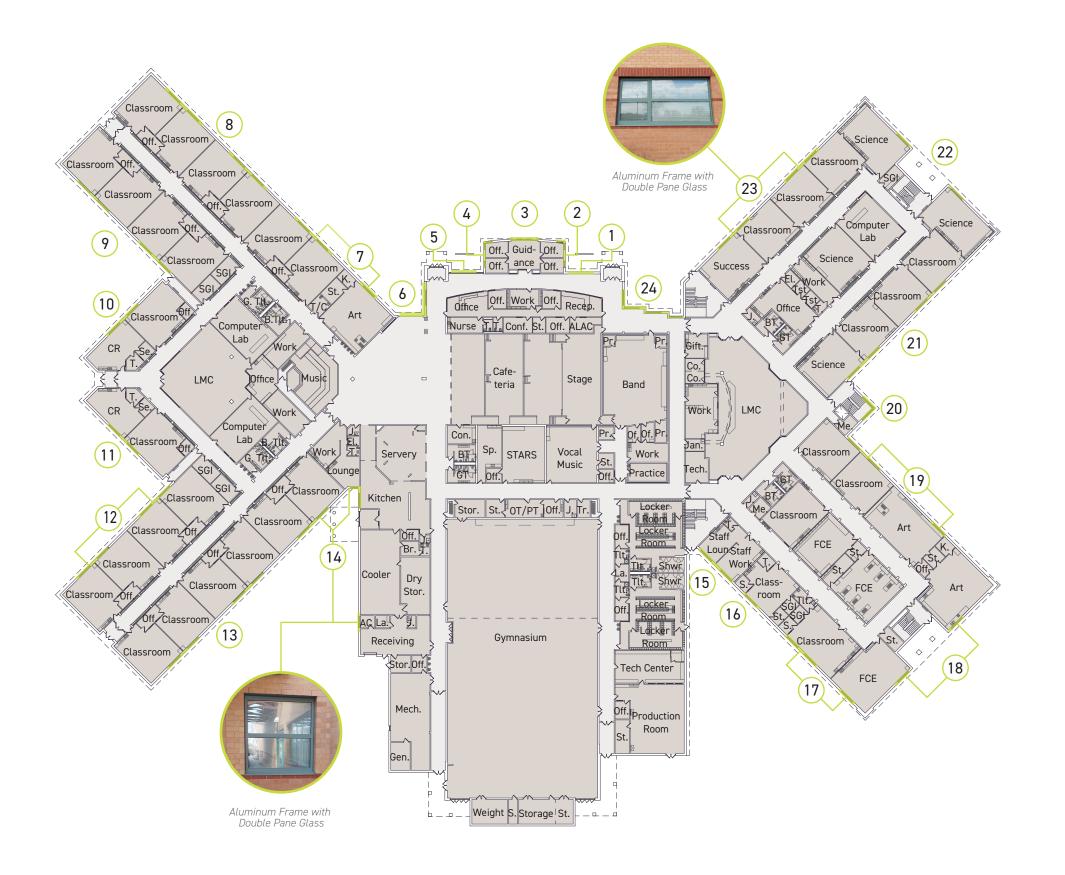
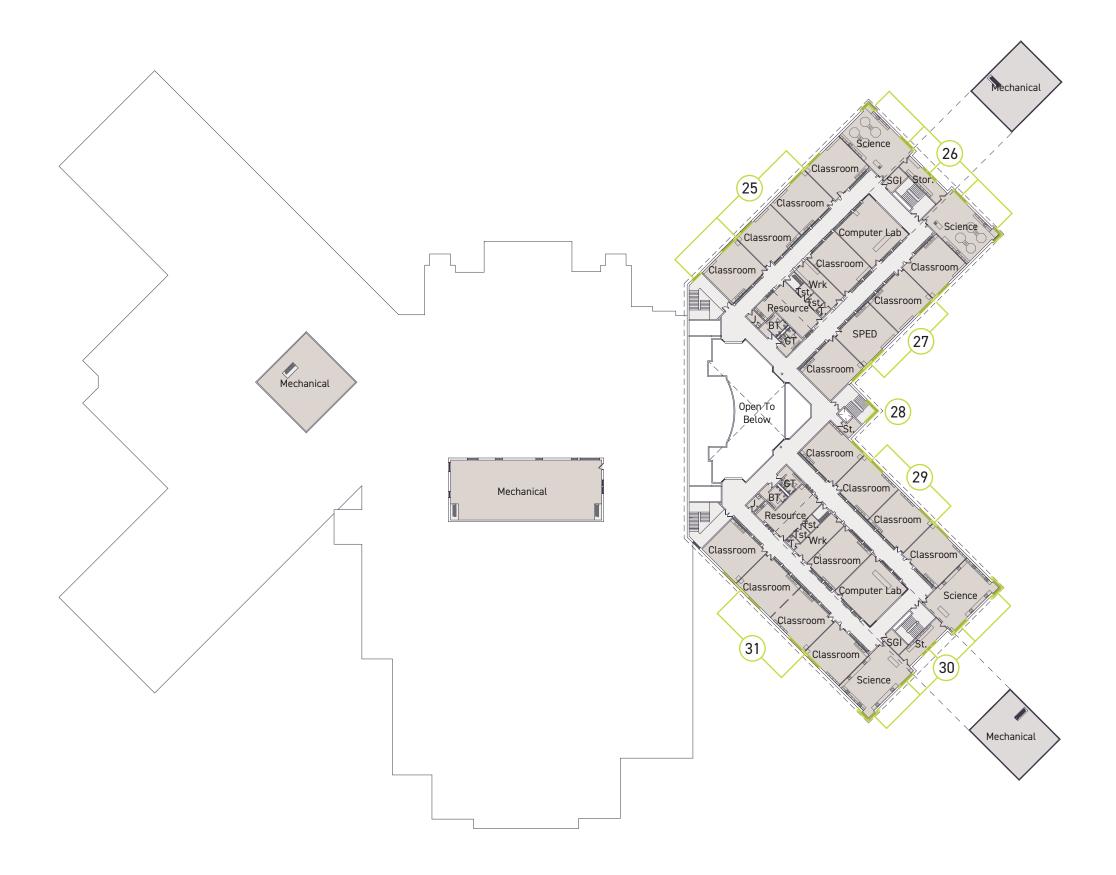
meadowview middle school exterior window identification + analysis | first floor

All of the aluminum framed windows with double pane glass are in fair condition due to fading, minor instances of scratching or denting, and worn sealant.

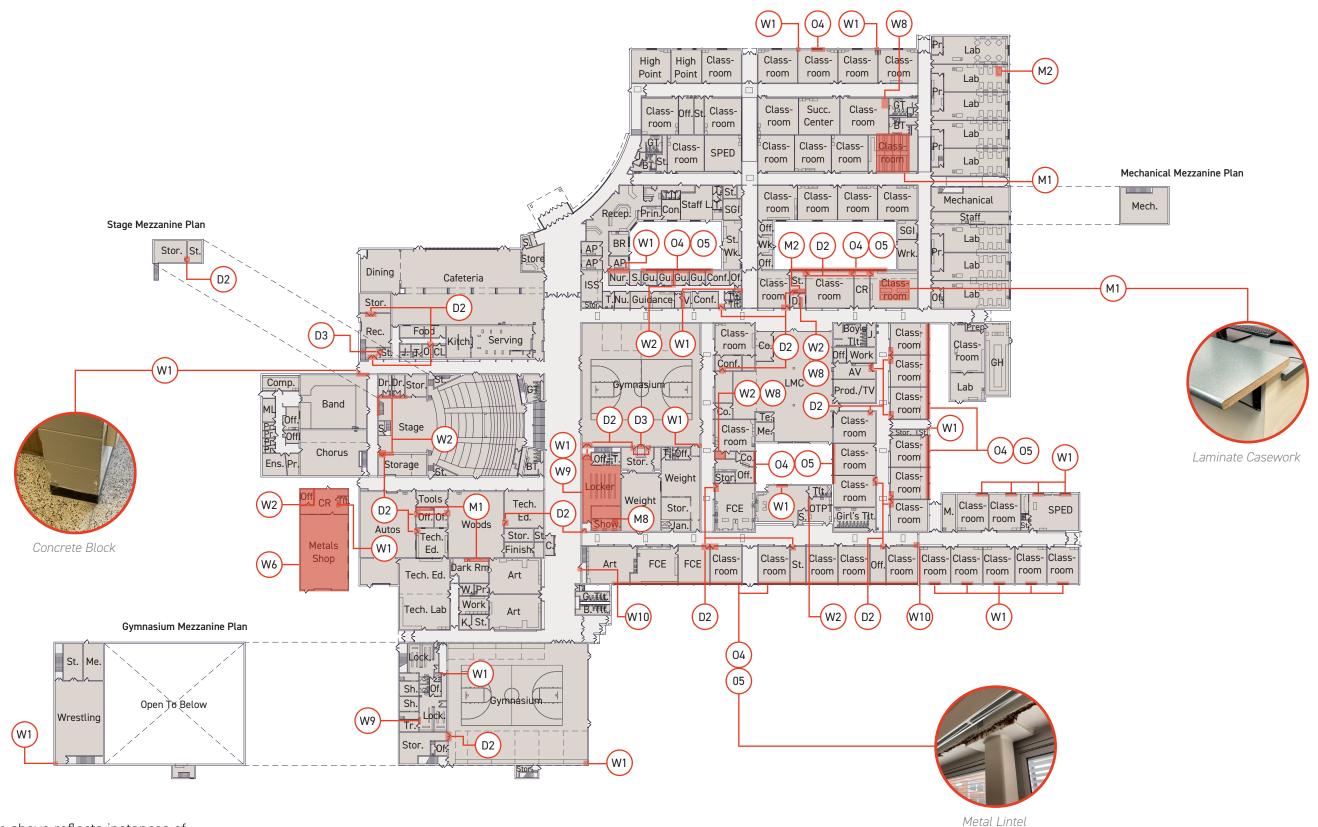
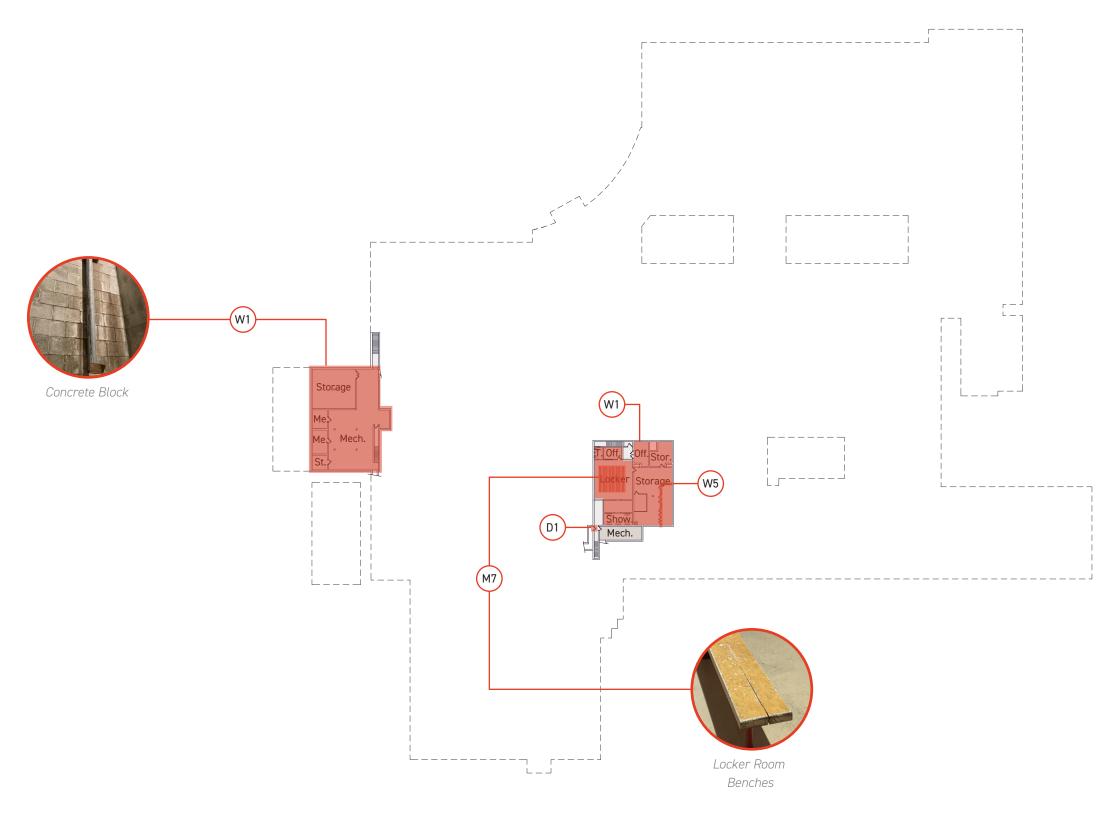
sparta high school interior identifications + analysis | lower level

- · Majority of the metal lintels located in the original 1962 building are in poor condition due to rusting and staining.
- The wood doors with hollow metal frames are in fair condition overall, but there are many instances of poor condition due to scratching, denting, and fading.
- Majority of the gypsum walls located throughout the building are in fair condition, except a few instances that are in poor condition due to cracking and chipping of paint.
- · There are few instances of concrete block in poor condition due to chipping, cracking, and scratching.
- The concrete block above the windows in the south portion of the 1990 addition are in poor condition due to cracking.

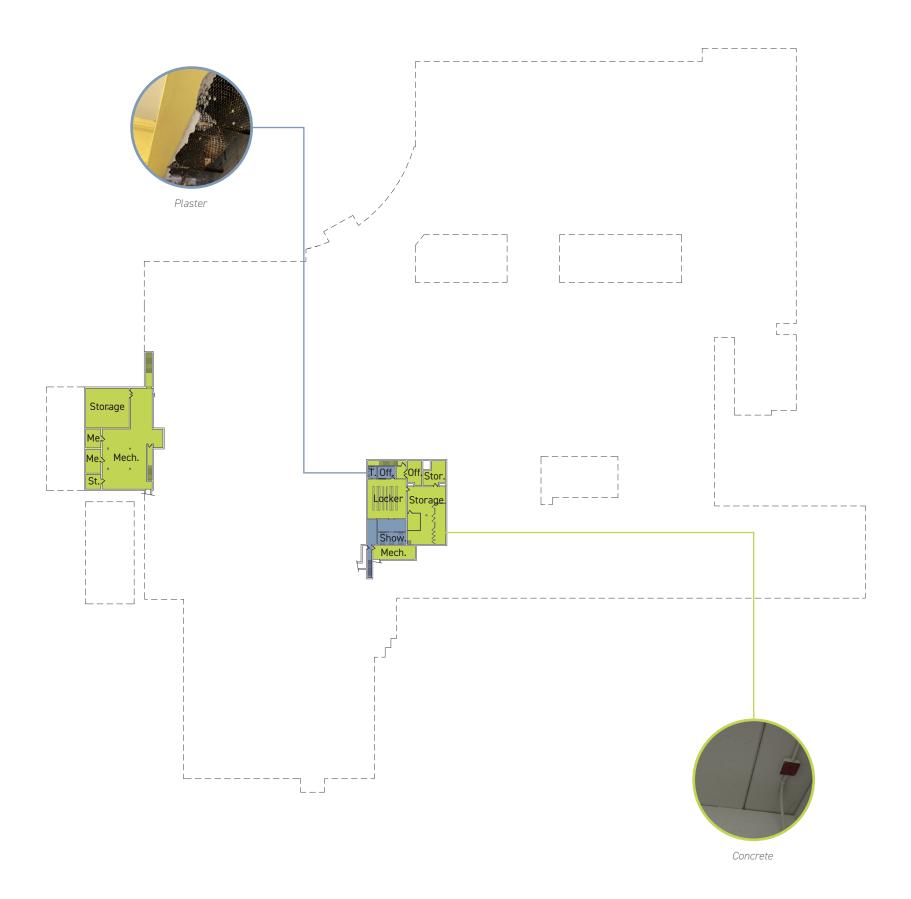
- Materials identified as potentially containing asbestos are considered to be in poor condition.
- Spline ceilings are identified as a potential asbestos containing material.
- Majority of acoustical ceiling tile located in the north side of the school are in good condition due to few instances of staining or warping.
- Majority of classrooms with concrete ceilings are in poor condition due to cracking.

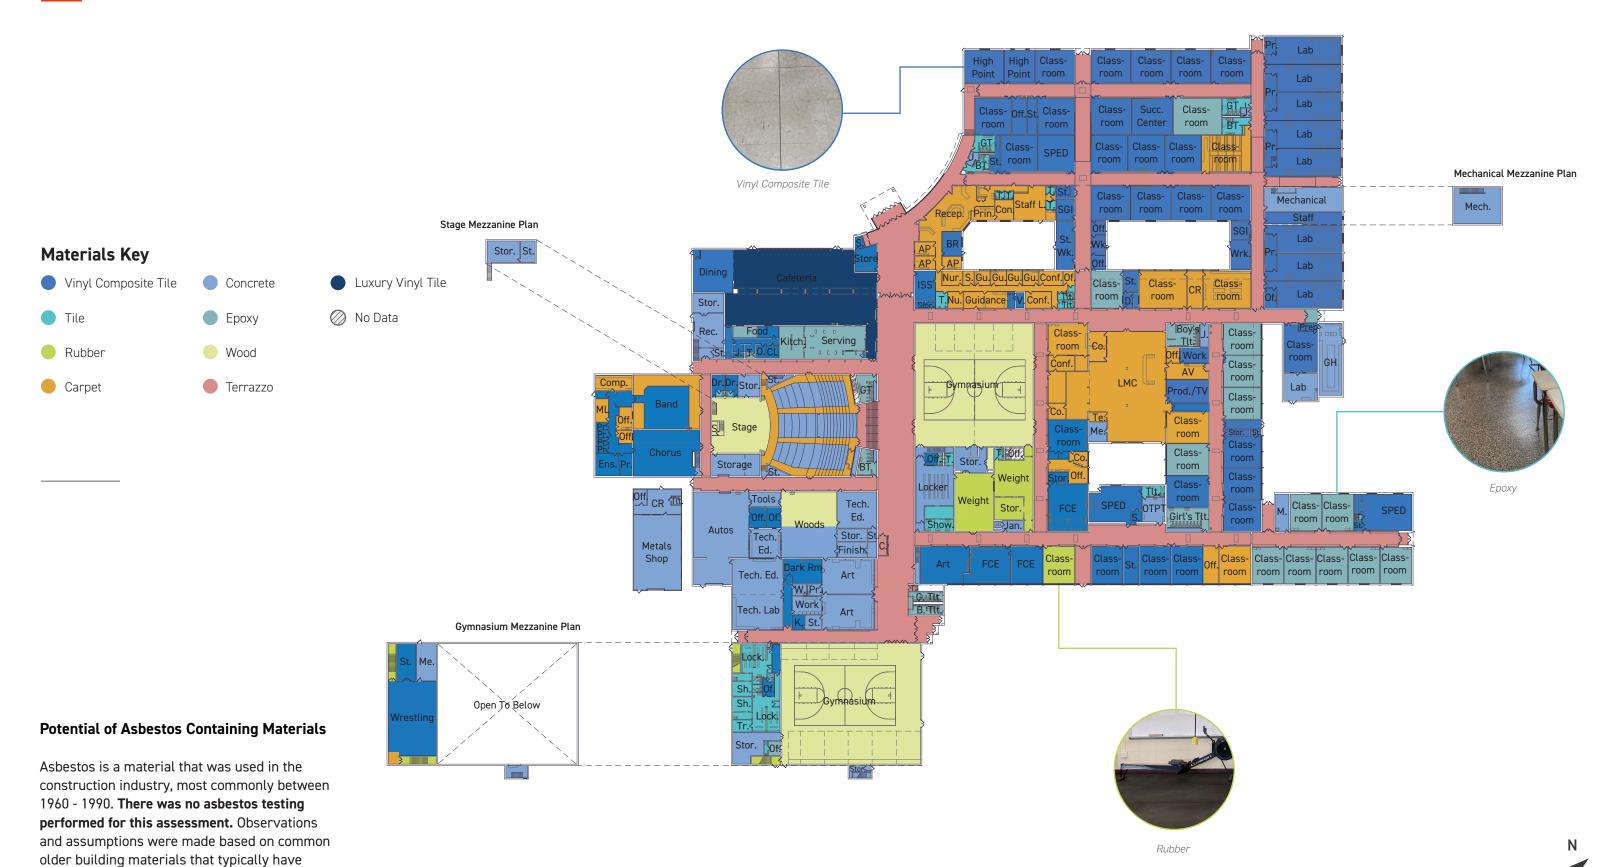
sparta high school flooring material identification

- Materials identified as potentially containing asbestos are considered to be in poor condition.
- 9" x 9" vinyl tile flooring is identified as potential asbestos tile.
- There are instances of concrete flooring located in the lower level that are in poor condition due to cracking and staining.
- Majority of VCT flooring is in fair condition due to minor scratching and wear.

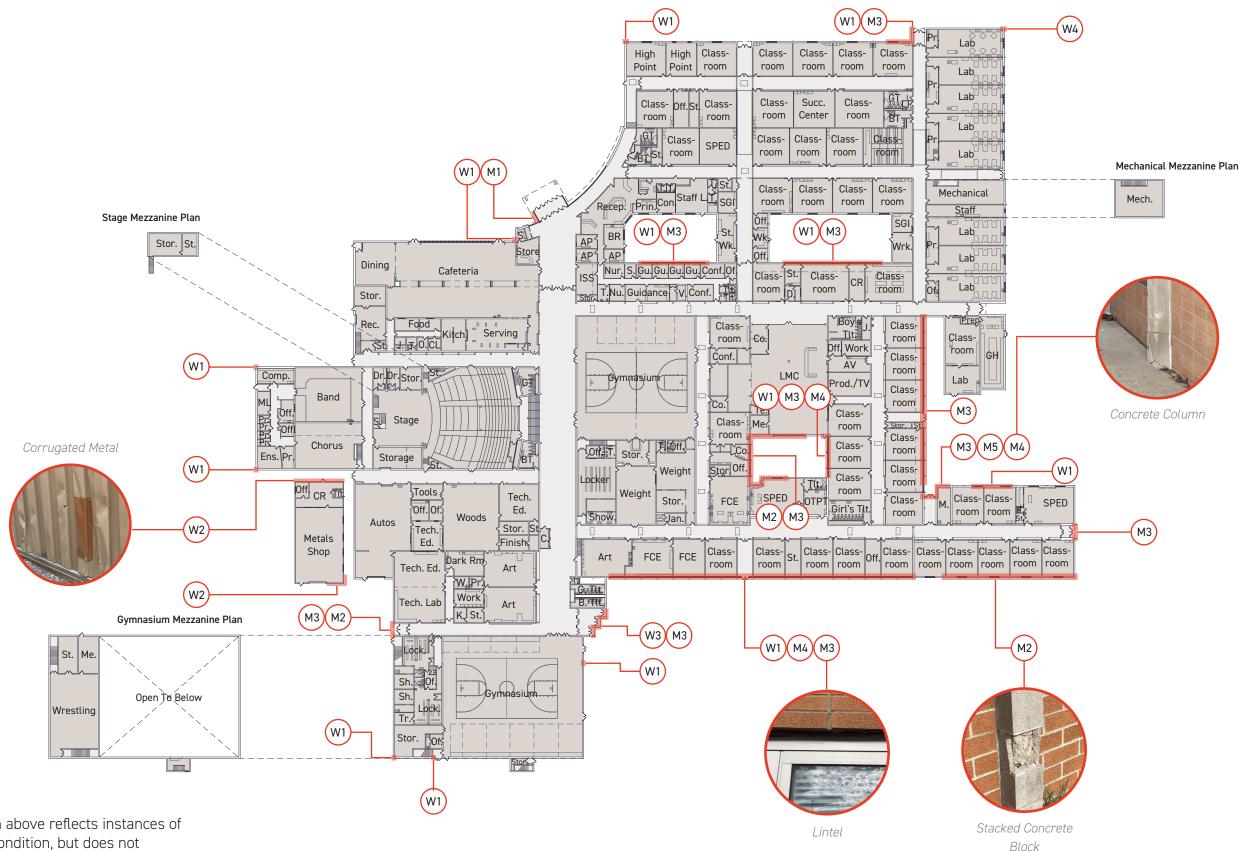
sparta high school exterior identifications + analysis

- Brick work contains cracking and chipping sporadically throughout exterior. Brick work on southwest side on original building portion shows signs of bowing/bulging.
- · Majority of the metal lintels located above the doors and windows are in poor condition due to rusting.
- Concrete columns and stacked concrete blocks are in poor condition due to cracking and crumbling.
- Corrugated metal facade of the industrial arts building shows excessive denting, scratching, and puncturing.

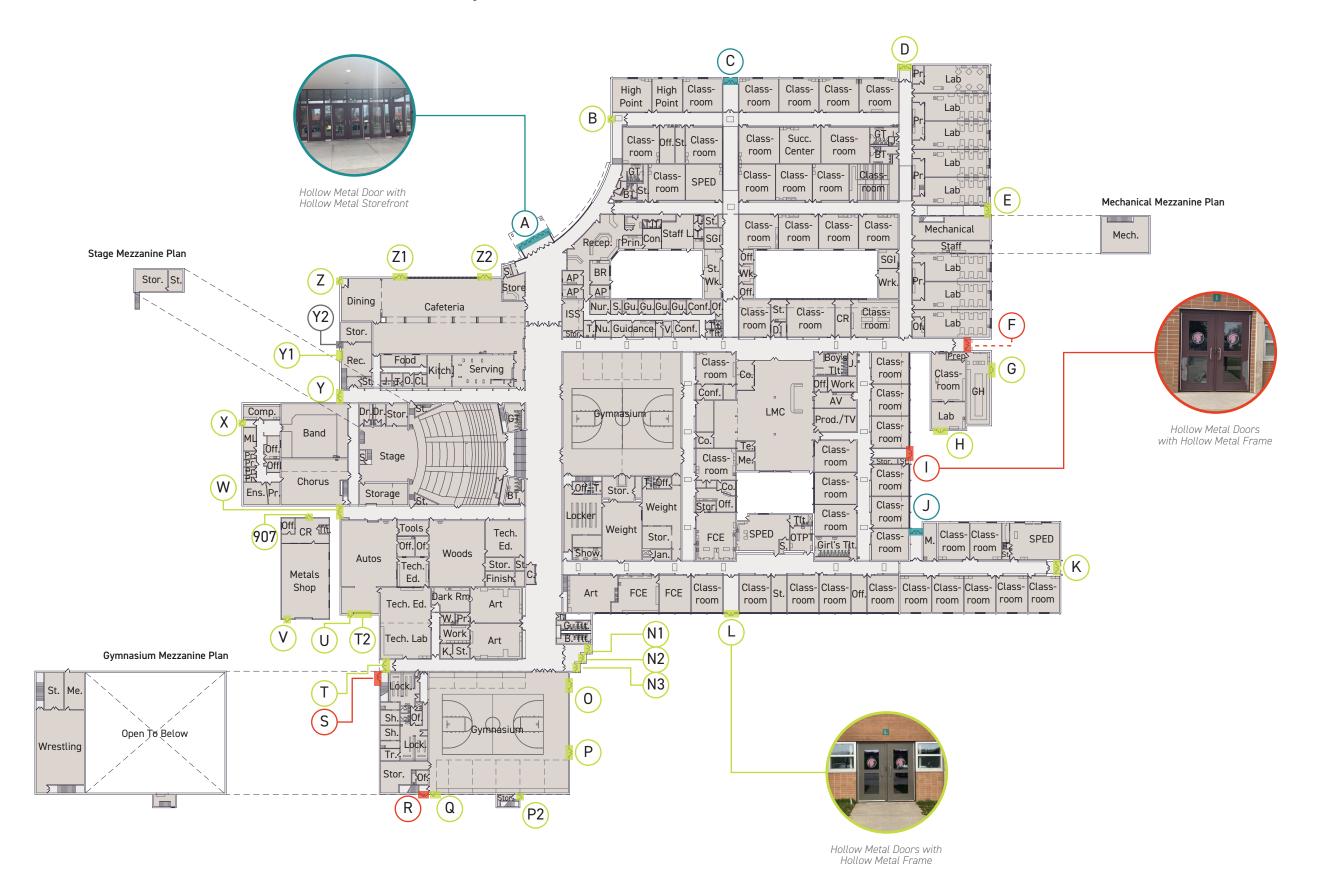
sparta high school exterior door identification + analysis

- The gymnasium exterior doors are in fair or poor condition due to rusting, staining, denting, or peeling of paint.
- Door I is in poor condition due to paint peeling, rusting, and broken glazing.
- Majority of hollow metal doors with hollow metal framing are in fair condition due to scratching of paint or fading of color.

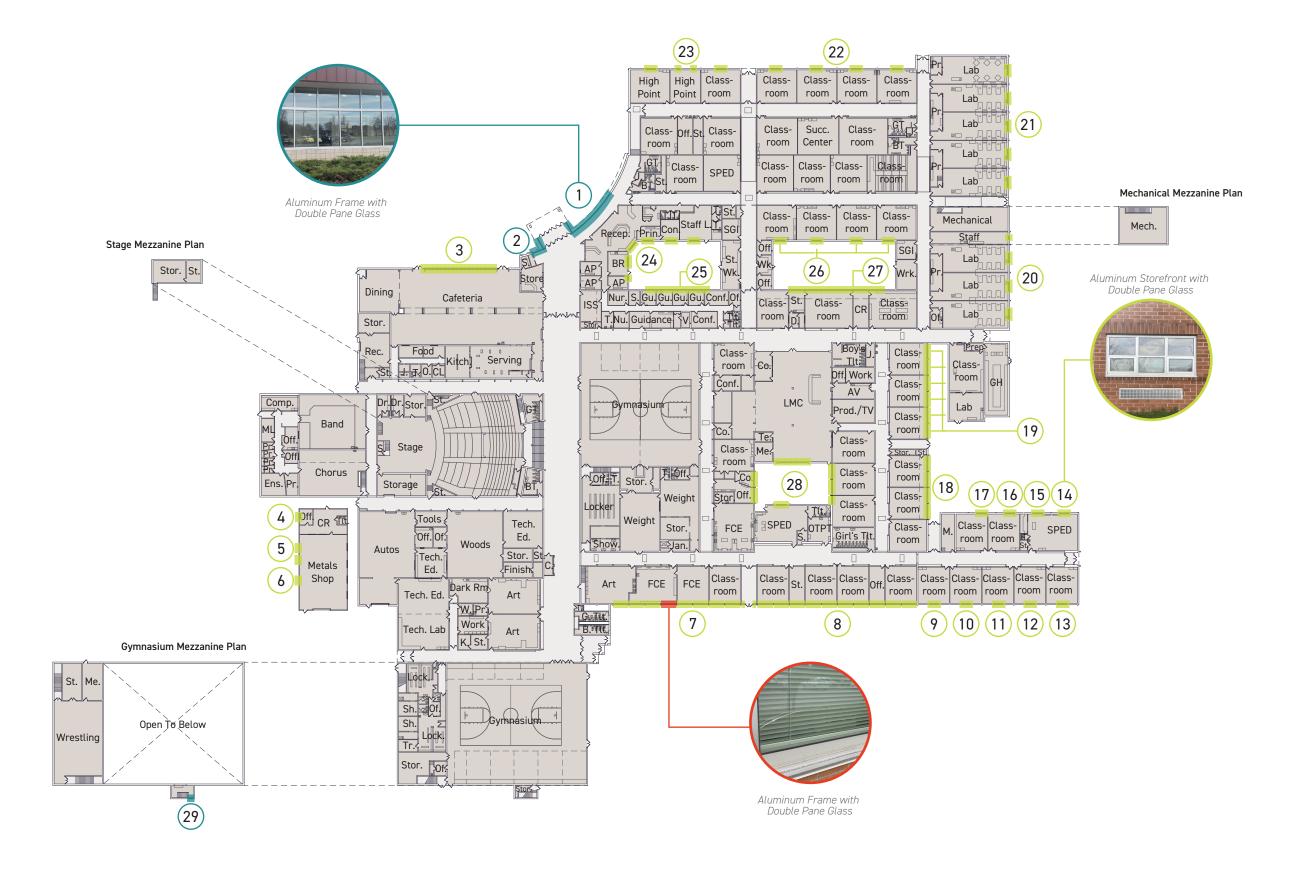
sparta high school exterior window identification + analysis

- Majority of the aluminum framed windows with double pane glass are in fair condition with slight wear and occasional rusting.
- There is an instance at windows 7 where a crack is visible.

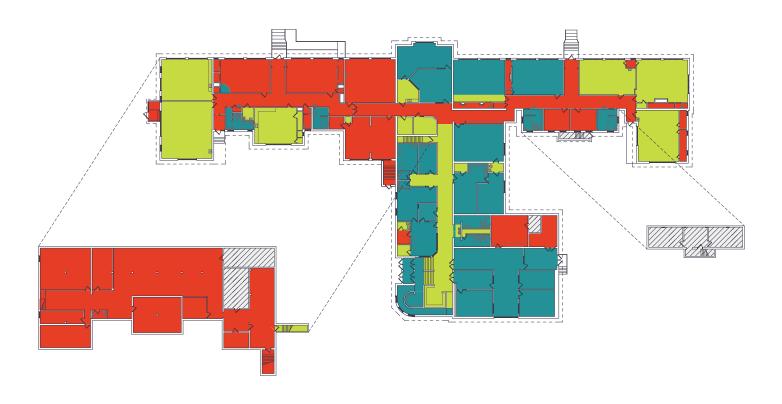
First Floor

- Materials identified as potentially containing asbestos are considered to be in poor condition.
- Carpet flooring located in classrooms is in poor condition due to staining and wearing.
- Terrazzo flooring located in hallways and restrooms are in poor condition due to cracking and staining.
- Concrete flooring located in the janitor's room is in poor condition due to cracking, crumbling, and staining.

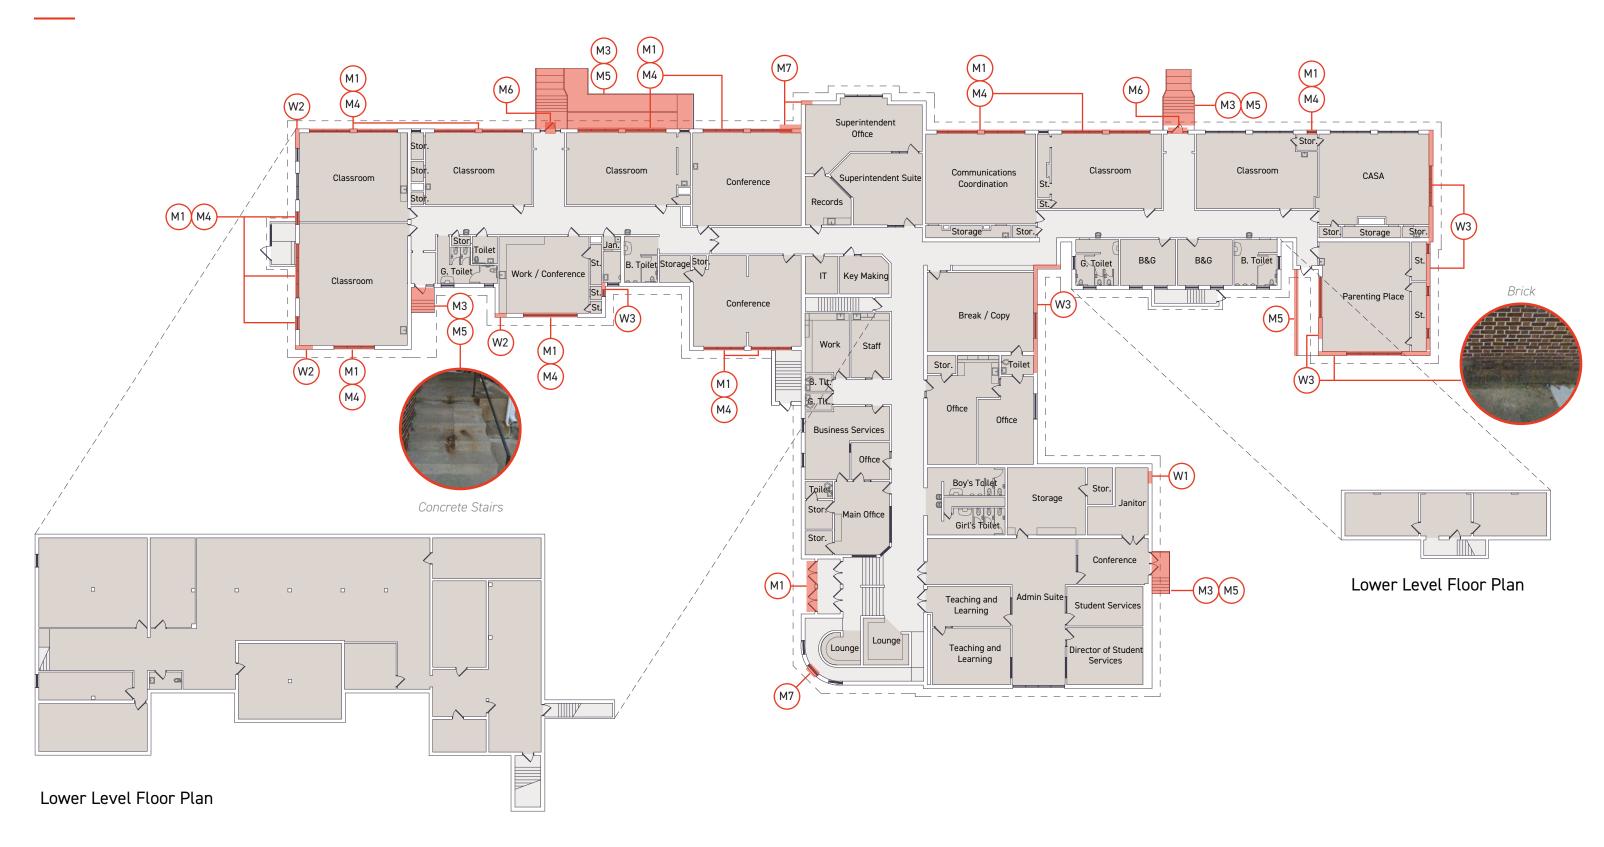
- · Majority of metal railings are in poor condition due to rusting.
- · Some areas of brick, typically located lower on the wall, are in poor condition due to staining, cracking and crumbling.
- The wood trim located on the western side of the building is in poor condition due to cracking and peeling.
- · Majority of metal lintels located above the windows are in poor condition due to rusting and staining.

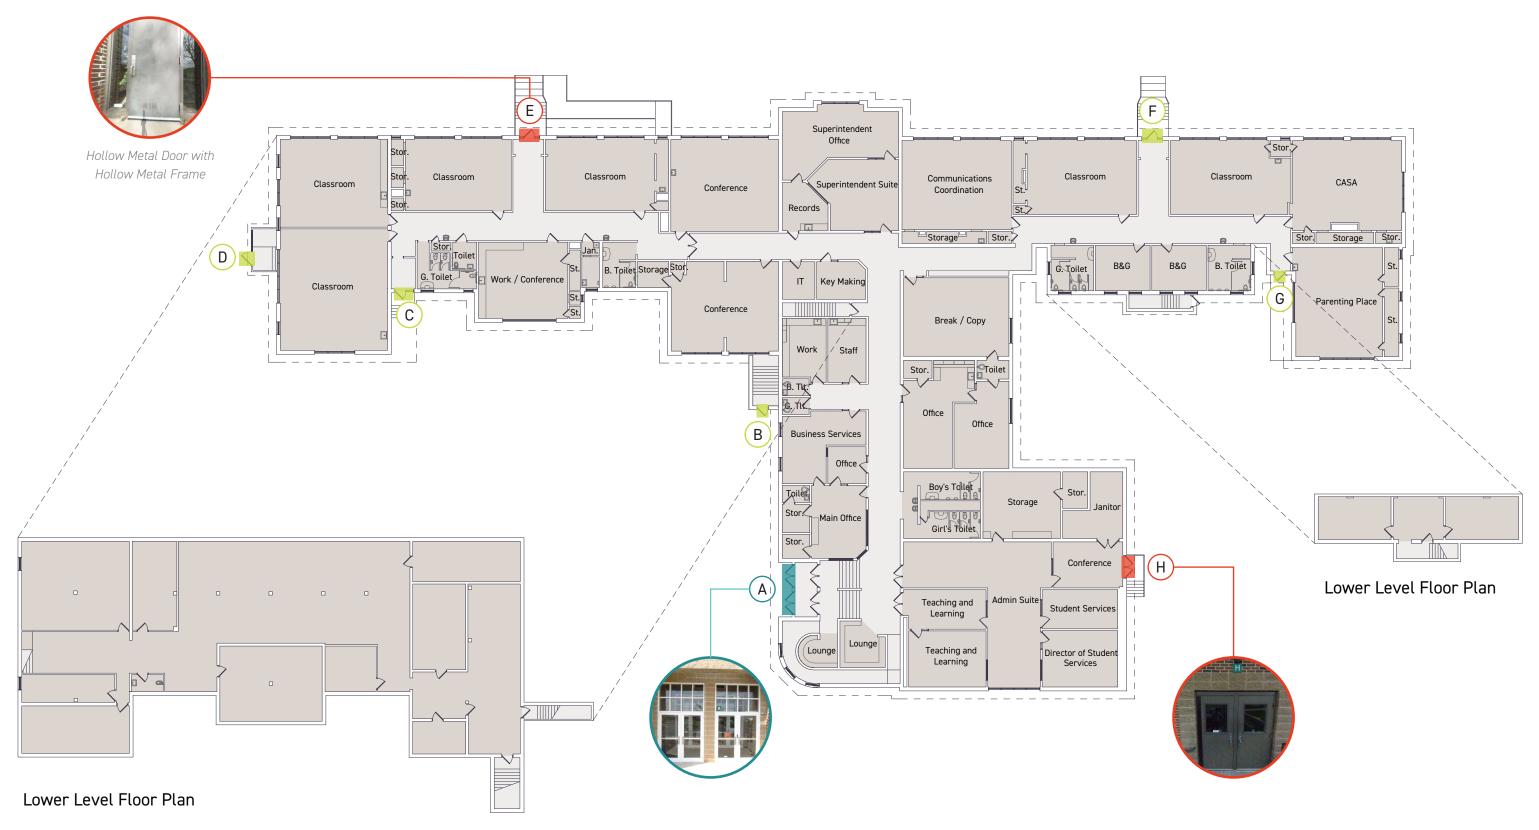
- Door E is in poor condition due to rusting and discoloration.
- Majority of hollow metal doors are in fair condition due to minor wearing.

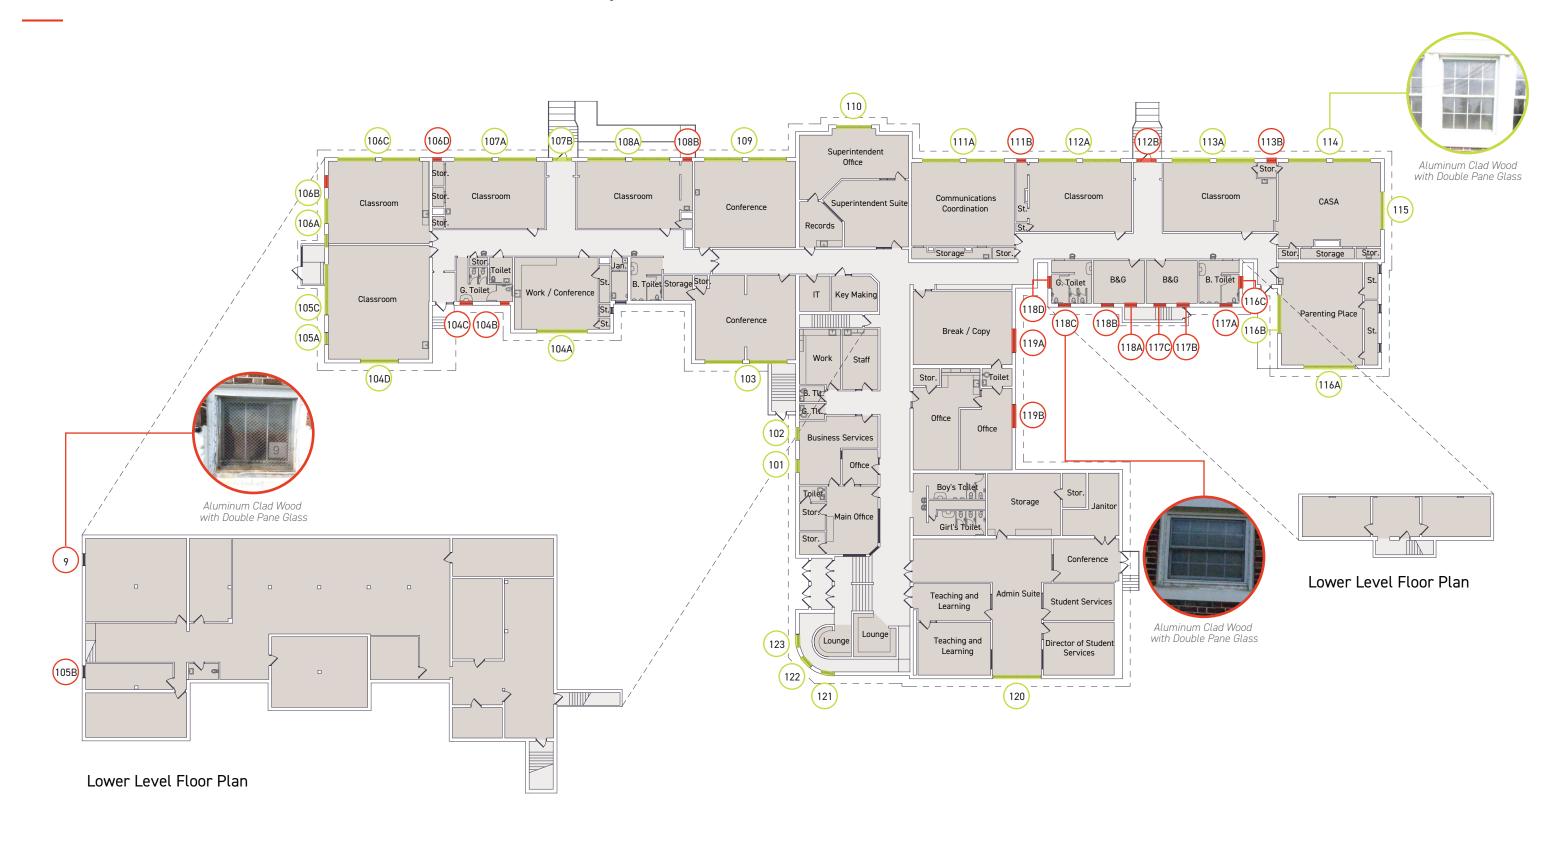
- Majority of windows in poor condition are due to staining and cracking.
- Window 111B is in poor condition due to broken glass.

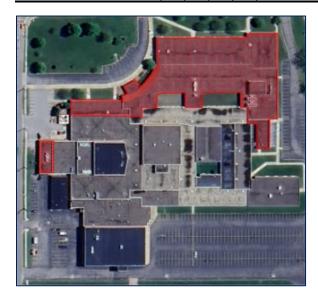
At isolated locations, pitch pans were installed at pipes/conduits that penetrate the roof. The pourable sealer within these pith pans has separated from the pipe and can potentially allow moisture to enter the roof system. (Refer to photograph #32).

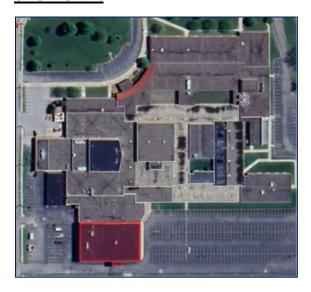
Membrane bridging is begging to occur at the majority of the roof to wall transitions. As the roof system ages and contraction of the membrane cause the base termination to fail, the membrane tents or bridges and placing stress on the flashing and seams. Repairs have been completed at several roof to wall locations. At one location with Area 25 an open flashing joint was observed at a repair. (Refer to photograph #44).
